“Zero” inflow and possible untreated sewage discharge at Burford STW on December 27th 2017

Peter Hammond, March 11th 2019

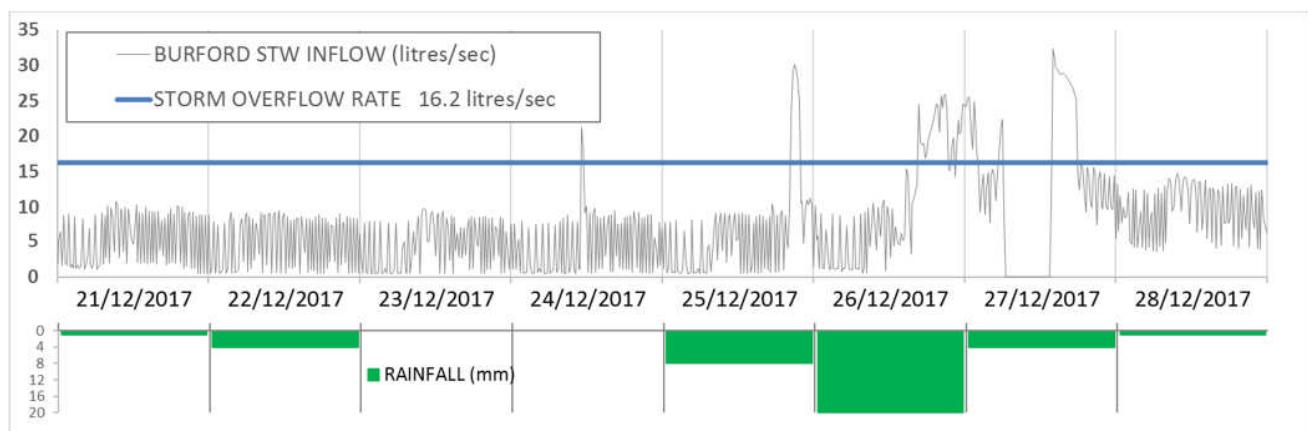
Figure 1 “Inflow” (Burford STW) and rainfall (Brize Norton) 21-28 Dec 2017 (incl)

For about 7 hours, approximately between 06:30 and 13:30 on Dec 27th 2017, the inflow was recorded as “zero” (Fig. 1). This was related by Peter Hammond and Ashley Smith in a briefing meeting to members of Burford Council in early Nov 2018 who later raised the issue in a separate meeting with TWUL’s External Affairs and Sustainability Director, Richard Aylard, on Nov 7th 2018. In an email reply to Burford Council, in early December 2018, Mr. Aylard reported the following:

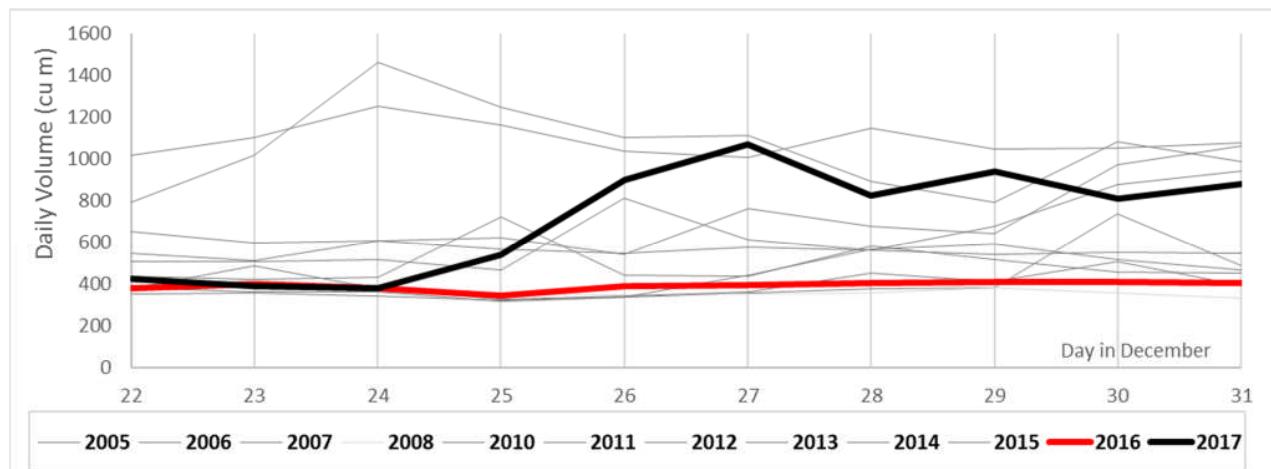
Figure 3: daily flow at Burford STW for Dec 22 to 31 for each year 2005-2017 apart from 2009

The years 2016 and 2017 have been highlighted as 2017 (in black) is the year of interest and 2016 (in red) shows daily volumes that are unaffected, in comparison to 2017, by rainfall as in the relevant period it was zero or very low (Fig. 4).

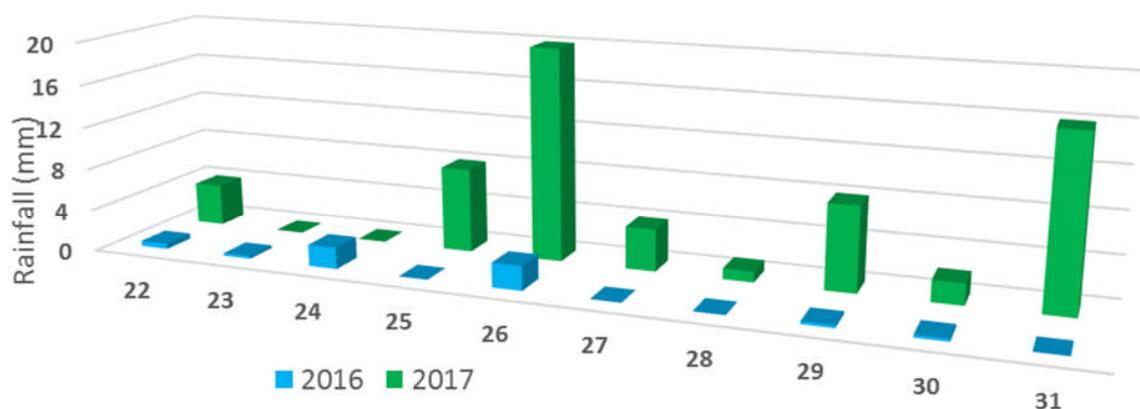
Figure 4: rainfall comparison at Brize Norton for Dec 22nd to 31st for 2016 and 2017
