NORTHLEACH SEWAGE TREATMENT WORKS

Peter Hammond, WASP, January 1st 2020

SUMMARY

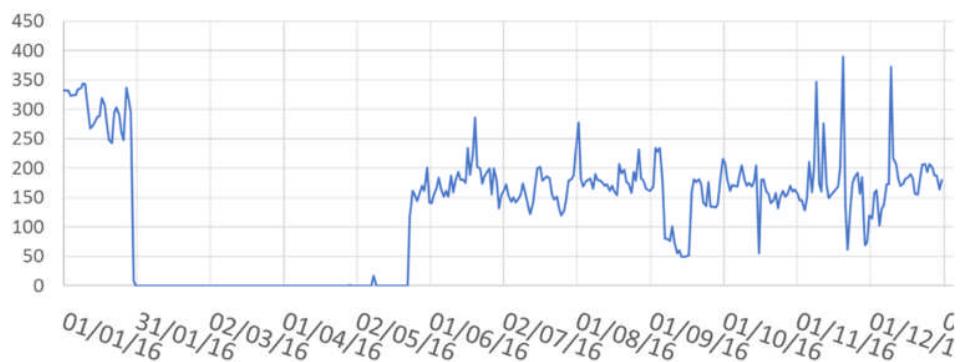
WASP's attention was drawn to Northleach STW in autumn 2018 when effluent flow data for 2016 was provided by TWUL under EIR_4_12. It was immediately noticed that the treated flow out of the works was recorded as "zero" between January 31st and May 23rd 2016 as in Fig. 1 below:

Figure 1: zero recorded effluent flow at Northleach STW Jan 31st to May 23rd 2016

When WASP highlighted this long period of "zero" outflow at meetings separately with TWUL and EA staff, both suggested a faulty flow meter as a likely explanation. Flow meters are vital to checking permit compliance and for both to accept such a long period of malfunction was very surprising. Water companies are obliged by their EA permit to treat a minimum rate of flow, record and report flow data regularly, ensure flow recording equipment is in good order, remedy faults in flow metering promptly and explain significant breaks in flow data acquisition.

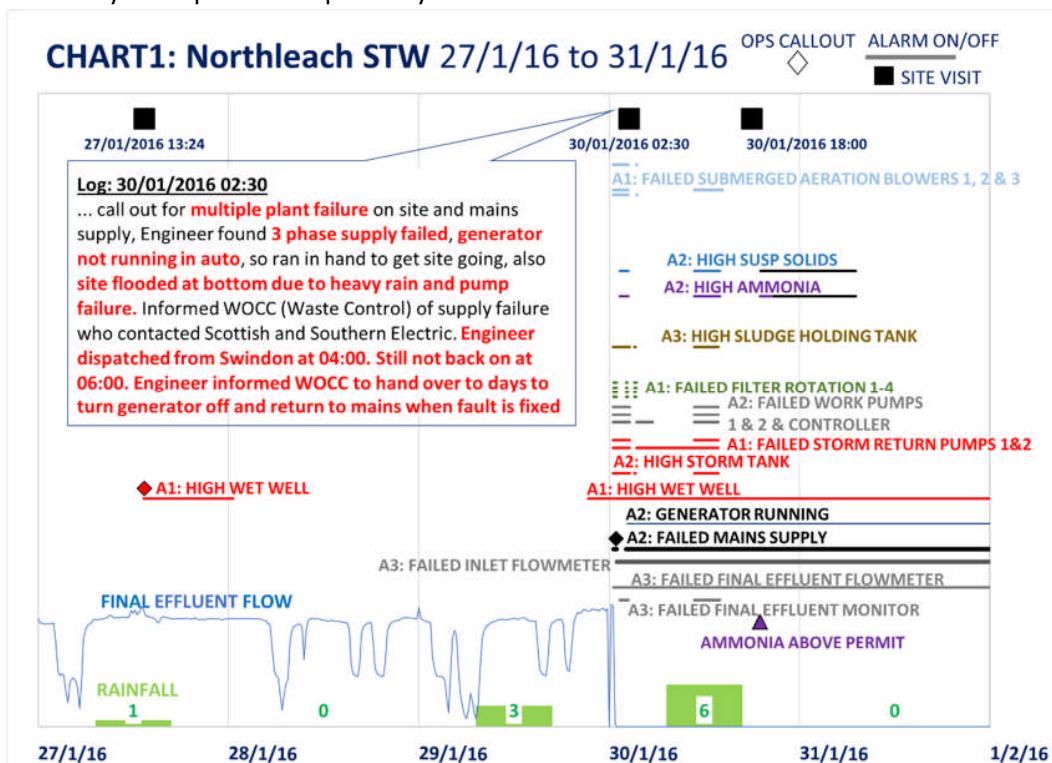
The mains power supply to Northleach STW failed on Jan 30th at 00:24, returned intermittently and at 03:22 failed for a further 8 hours. As the log reports show (CHART 1), the generator did not operate automatically but had to be started manually by an engineer called out to the works.

For an hour or so, the site had no power and various pumps failed and alarms were set off. Without power, raw sewage could not be passed to treatment so it overflowed to the storm tank for 2 hours (there was little rain). The pumps emptying the storm tank failed, the wet well high alarm was already raised and the storm tank was high for 3 more hours. For these 5 hours, the average effluent volume that would have been passed to treatment was close to storm tank capacity. Given that the storm tank was high and both storm tank return pumps had failed earlier in the month, the storm tank was not empty when this incident began.

As the messages in Table 1 confirm, the inlet flow and final effluent meters failed on January 30th and were not working until 18th July and April 29th respectively.

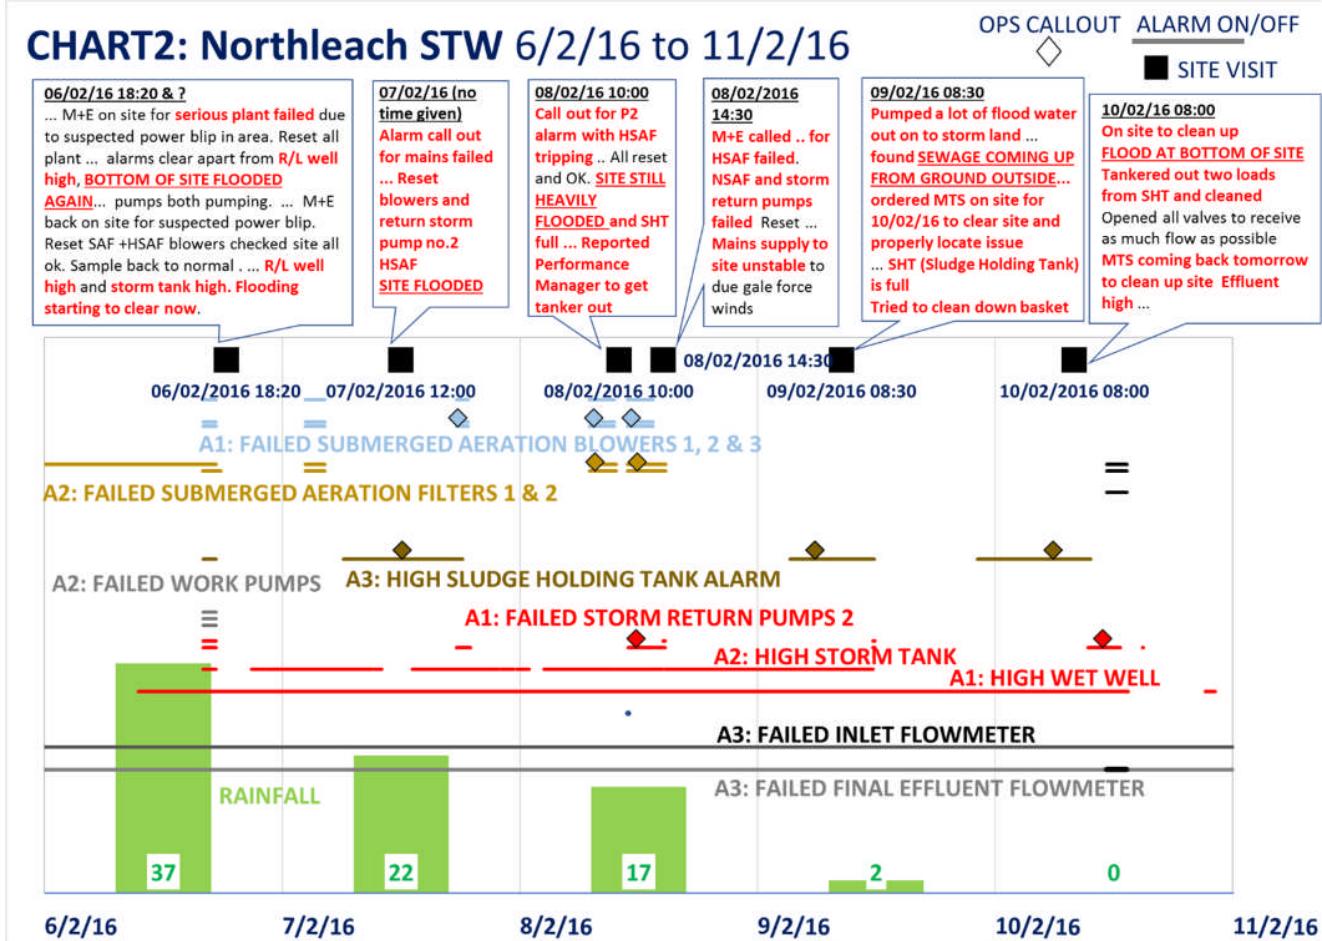
CHART2: Northleach STW 6/2/16 to 11/2/16

Between Feb 6th and Feb 10th 2016, Northleach STW was again heavily flooded. Once more, a power surge had badly affected equipment on site – described by the visiting operator on Feb 6th as “serious plant failed (sic)”. Repeated operator visits were required, the storm tank high alarm (severity A2) was set for more than 2 days and the storm return pump failure (severity A1) for almost 4 days (see CHART 2) – such alarms should be cleared by the WOCC within 90 and 60 minutes respectively. Given the high rainfall, the inevitable untreated sewage spill would likely fall within permitted “storm conditions”. However, disturbingly, on February 9th 2016 the operator noted the following:

*Pumped a lot of flood water out on to storm land ... found **SEWAGE COMING UP FROM GROUND OUTSIDE**... ordered MTS on site for 10/02/16 to clear site and properly locate issue*

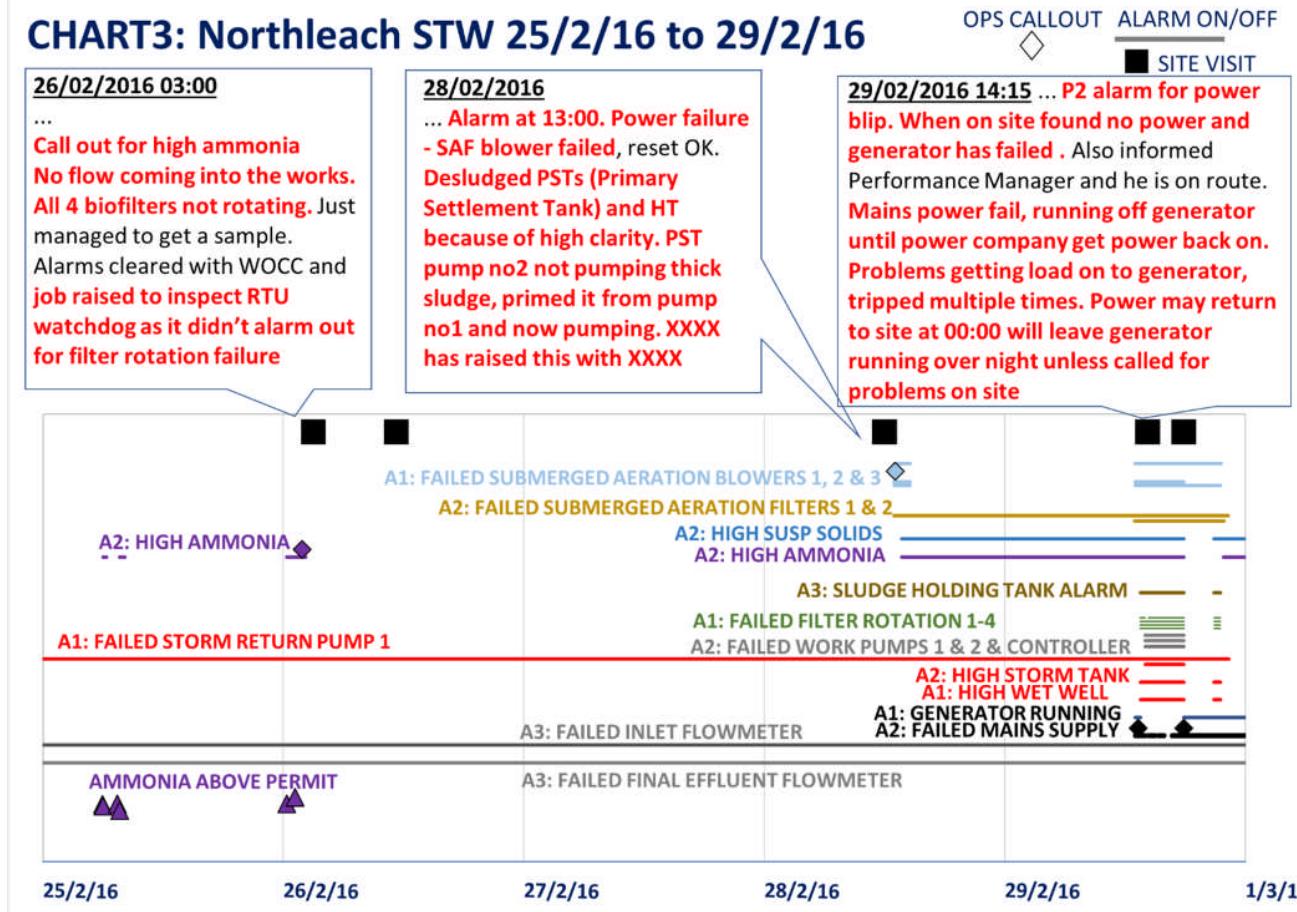
CHART3: Northleach STW 25/2/16 to 29/2/16

The log report of 26th February 2016 at 03:00 in Chart 3 below describes an incident where the failure of multiple components (all 4 rotational biofilters) did not raise alarms. It also says that there was "no flow coming into the works".

The log reports of 28th and 29th February mention further power failures and the second describes how the operator arrived to find both mains power and a backup generator failed. As can be seen in Chart 3 below, this left the site with no power and resulted in untreated sewage being passed to the storm tank whose alarm was set high from 13:31 to 17:53 and from 20:53 to 21:31 with a full wet well and both pumps for emptying the storm tank without power and failed. In that period, the untreated flow volume would have been close to the 78 cu m capacity of the storm tank. Therefore,

Once again, the remedial interventions to severity A1 alarms (storm return pumps, wet well, filter rotations 1-4, aeration blowers 1 and 2, generator) and severity A2 alarms (high ammonia, high suspended solids, aeration filters 1 & 2, storm tank, mains supply) alarms were well outside TWUL internal targets. The ammonia level in the treated effluent was above the permit level on five occasions on Feb 25th and Feb 26th.
