## 20 potential abuses of Operator Self-Monitoring of treated sewage to avoid permit breaches

Peter Hammond  
Windrush Against Sewage Pollution (WASP)  
Version 4 October 24<sup>th</sup> 2024

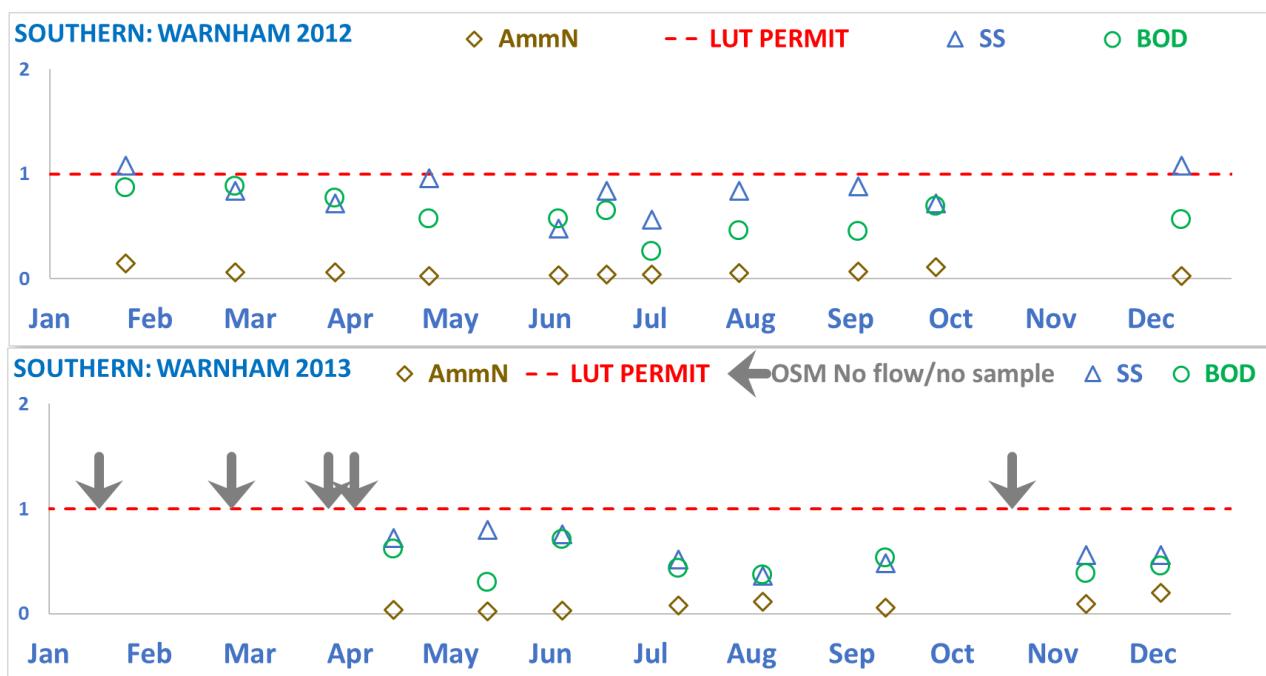
**Figure 1:** OSM sample results for Southern Water’s Warnham STW for 2012 and 2013 (LUT refers to a threshold for compliance obtained from a “Look Up Table” in the permit; in this case, the LUT threshold cannot be exceeded more than twice in 12 consecutive sample results; 2 suspended solids (SS) exceedances in early/late 2012 followed by a 3<sup>rd</sup> exceedance in early 2013 would have been a permit breach)

WASP has reviewed the OSM final effluent sampling data for 2012 and 2013 for Warnham STW (Fig. 1) which confirm that in 2012 there were two exceedances of the suspended solids (SS) permitted concentration so another at the beginning of 2013 would have caused the STW to be non-compliant and in breach of permit. In fact, four “no flow” OSM sampling attempts were recorded for Warnham STW at the beginning of 2013. The EA confirmed there was no evidence to suggest that the artificial “no flow” on February 26<sup>th</sup> was genuine. Indeed, it seems likely that one or more of the “no flow” samples would have exceeded permit limits. According to the EA, non-compliance with statutory permit conditions is illegal. The manipulation of sewage treatment flow or selection of favoured dates on which to undertake statutory sampling, so as to guarantee or improve the chances of compliance, may also be a criminal offence.

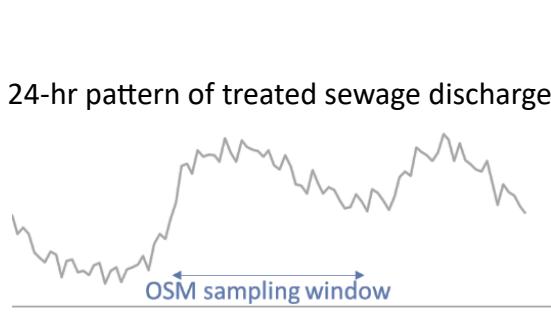
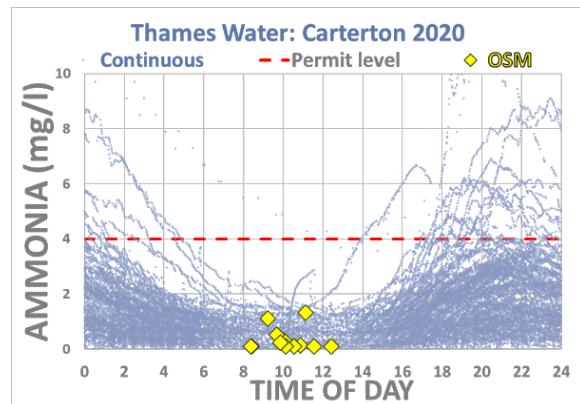
**Figure 2: a)** 24-hr pattern of treated sewage discharge; **b)** example of multiple potential breaches of a 95% permit limit for ammonia revealed by continuous monitoring whereas all 12 OSM samples are compliant.

Typically, in dry weather, the rate at which sewage arrives at a treatment works follows a regular diurnal pattern with one peak around breakfast time and another covering evening meal/bedtime (**Fig. 2a**). Between 7 am and 3 pm, the proportion of the daily volume of treated sewage discharged from a sewage works is approximately 40%-45%. For the remainder of a day, i.e., midnight to 7 am and 3 pm to midnight, about 55%-60% of treated sewage (by volume) is discharged. There are, of course, weather, regional and seasonal variations.

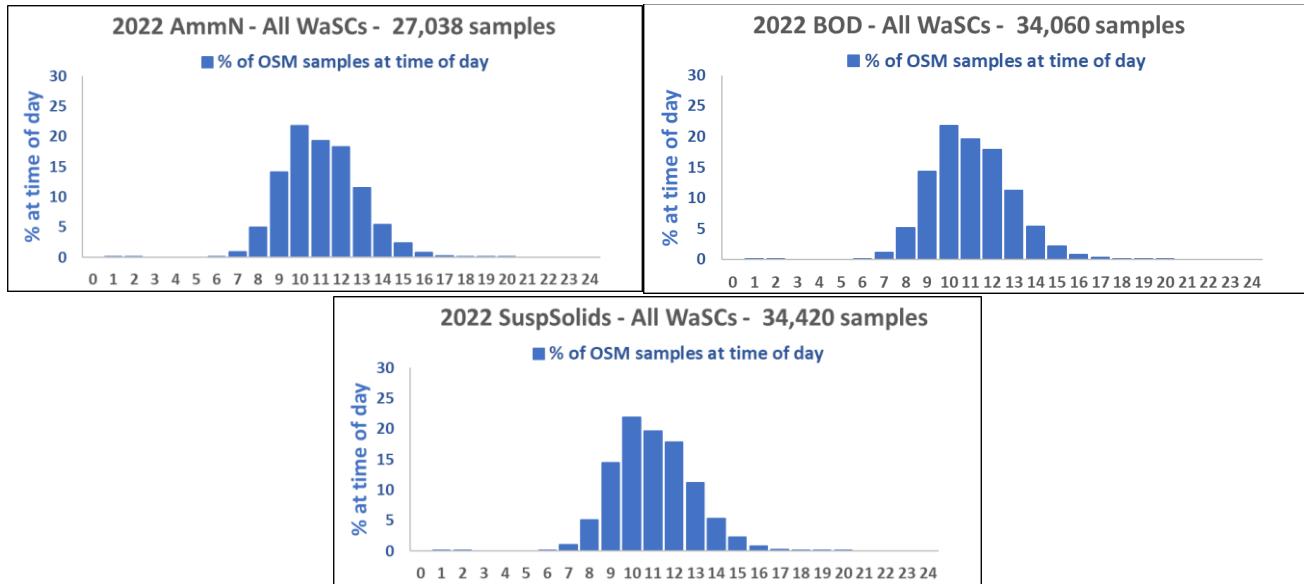
**Figure 3:** frequency of OSM spot sample times in 2022 by all WaSCs for ammonia, BOD and suspended solids

oxygen demand (BOD) and suspended solids (SuspSolids) by all water and sewerage companies (WaSCs). Note that the period 7am to 3 pm covers almost all sampling activity.

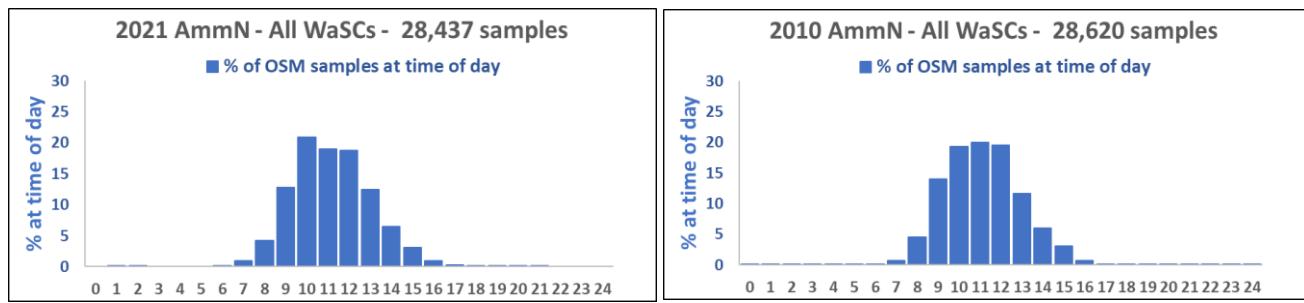
**Figure 4:** OSM spot sampling times in 2021 and 2010 for ammonia for all WaSCs

This limited monitoring of ammonia levels has been the case every year since OSM was introduced in 2009/2010 (Fig. 4). Given that multiple parameters are typically tested in each sample, this is also true for BOD, suspended solids and other final effluent quality parameters.

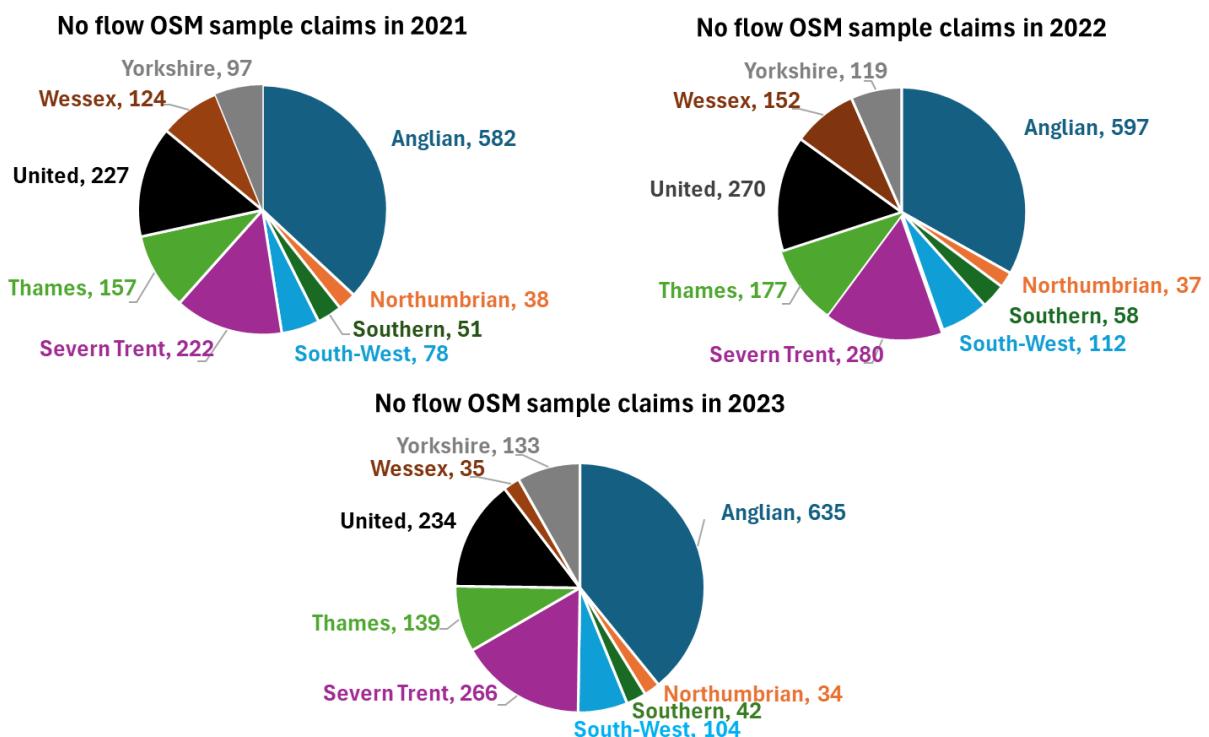
**Figure 5:** apportionment of no flow/no sample claims to each WaSC 2021- 2023

In 2022, only 2 WaSCs used a coding other than 0. Thames Water used code 1 for 7.3% and United Utilities used codes 1-3 for 40% of their “NO FLOW/NO SAMPLE” claims.

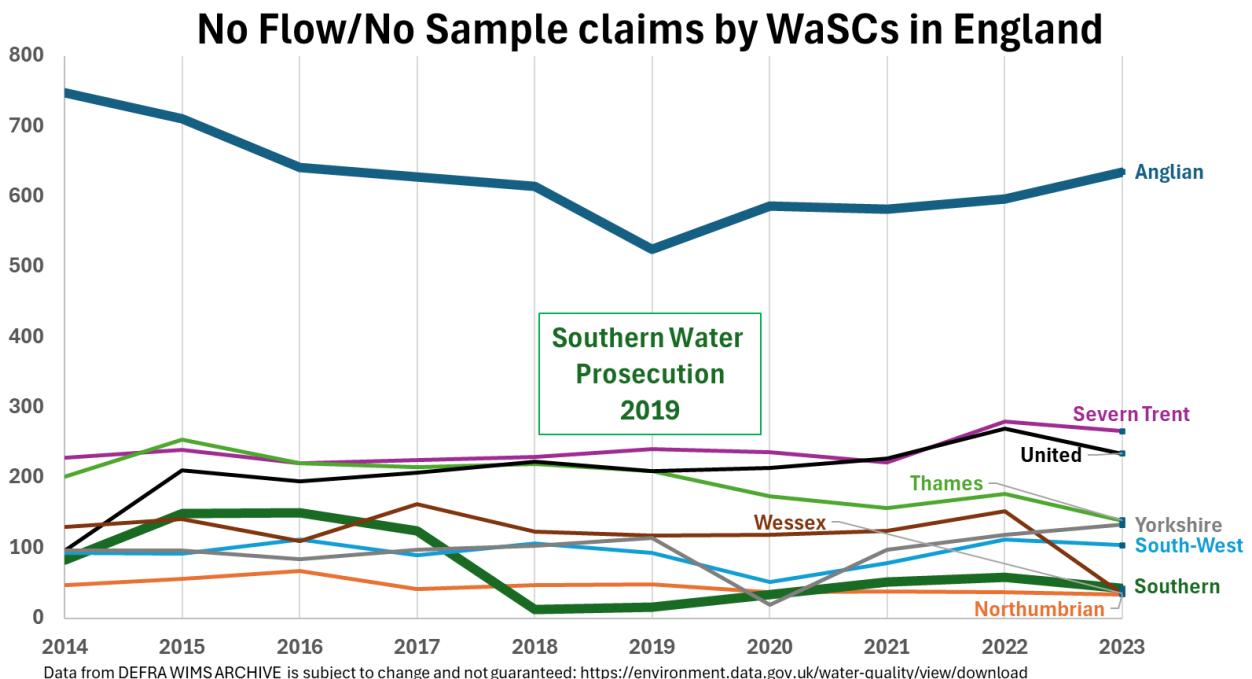
**Figure 6:** overview of no flow/no sample claims for each WaSC 2014- 2023

The effect of Southern Water's criminal conviction in 2019 for engineering artificial "No FLOW/NO SAMPLE" events can clearly be seen in its rapid reduction of the number of such claims just before and subsequent to the court case. Similar reductions in the number of "NO FLOW/NO SAMPLE" claims can be seen for most other WaSCs (Fig. 6). Thereafter, there is a gradual increase until 2022 when all but Anglian appear to reduce the number of claims. These figures are subject to continuing updates of the DEFRA WIMS database so may become out of date.

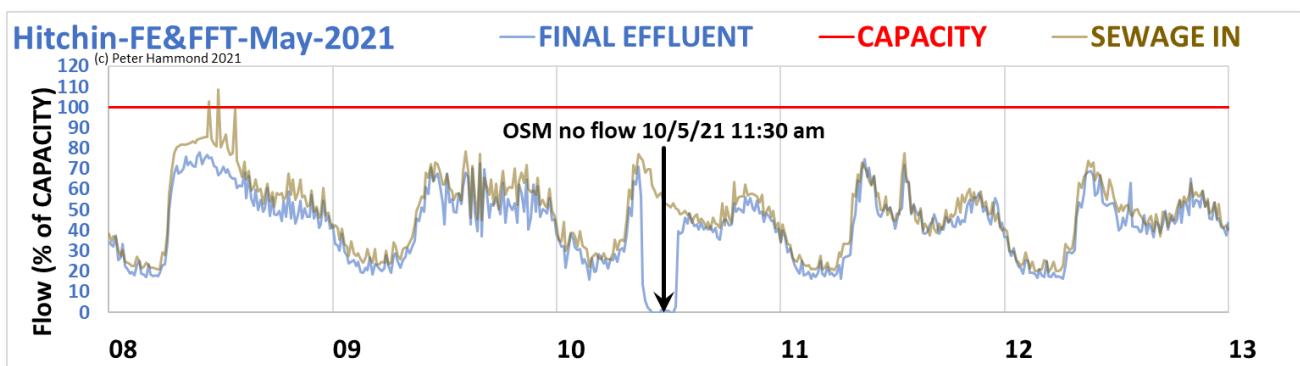
**Figure 7:** sewage flow and OSM no flow sample at Hitchen STW in May 2021 (final effluent flow (FE) drops to 0 just before and rises just after the “spot” sample attempt is recorded)

Figure 7 shows the flow of raw sewage being passed into treatment (SEWAGE IN) as well as treated sewage (FINAL EFFLUENT) leaving the STW over a 5-day period. The SEWAGE IN flow is unbroken, but the FINAL EFFLUENT flow, the treated sewage to be sampled, appears to drop abruptly to zero just before the sample is attempted and rise just as abruptly shortly afterwards.

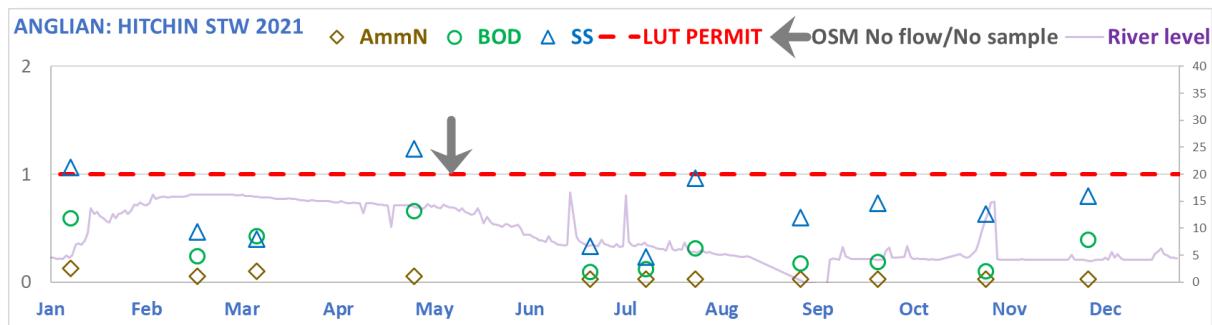
**Figure 8:** OSM sampling results for 2021 for Hitchin STW

On May 10<sup>th</sup> 2021, the day of the no sample claim, the river level was about 15 cms which seems unlikely to have caused flooding of the outlet.

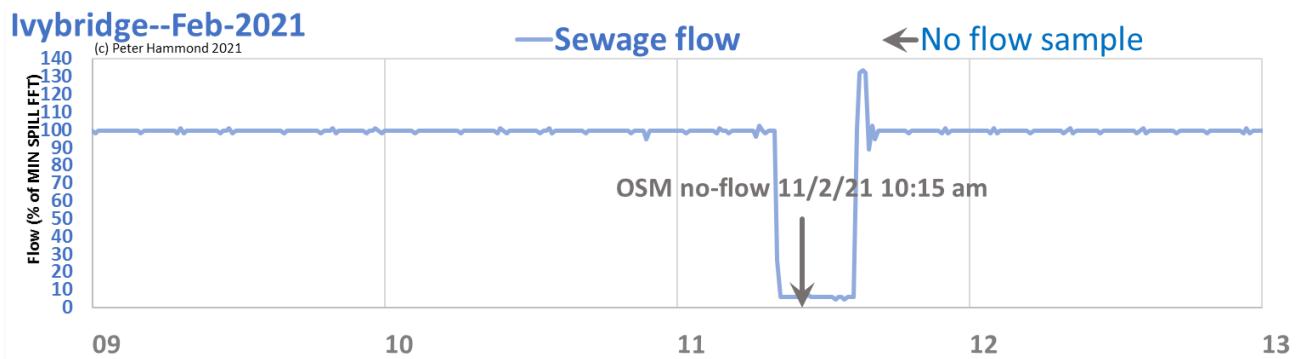
**Figure 9: final effluent flow and OSM no flow sample at Ivybridge STW in February 2021**

**Figure 9** shows the final effluent flow over a 4-day period including the day of the "no flow" sample.

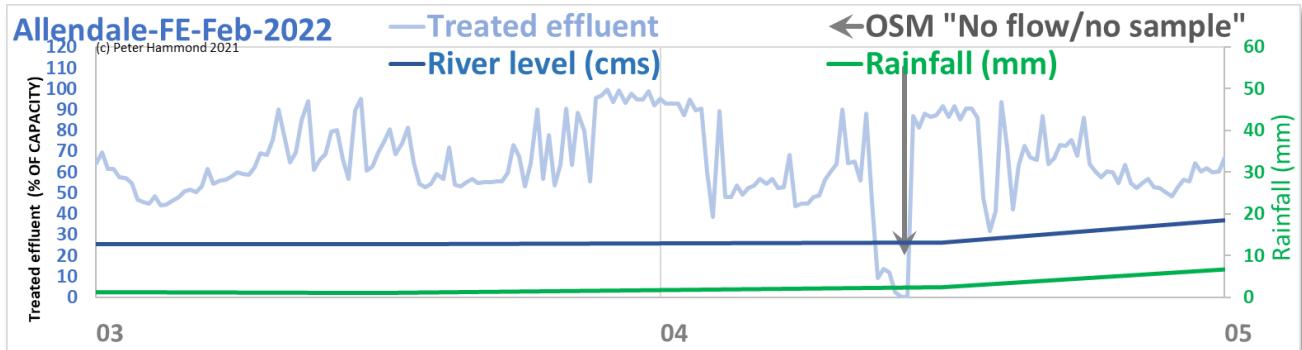
**Figure 10: treated effluent, river level, rainfall and a “no flow” OSM sample at Allendale STW in Feb 2022**

Figure 10 shows treated effluent, river level, rainfall as well as the “no flow” OSM sampling attempt within an interval when the treated effluent drops to zero and rises again steeply in a short period of time.

On the morning of 4th February 2022 Allendale Sewage Treatment Works experienced an air lock in the inlet pump and for a short period there was no flow being pumped to either the treatment stage or to the environment. This issue was quickly identified and was resolved the same day. The sample was reported as a ‘no flow’ to the Environment Agency, in accordance with their requirements. All of the eleven samples that were taken during 2022 from Allendale Sewage Treatment Works complied with the permit conditions.

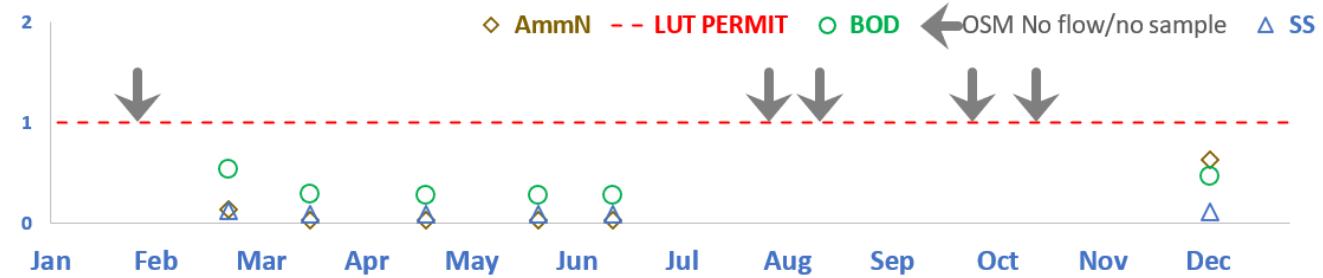
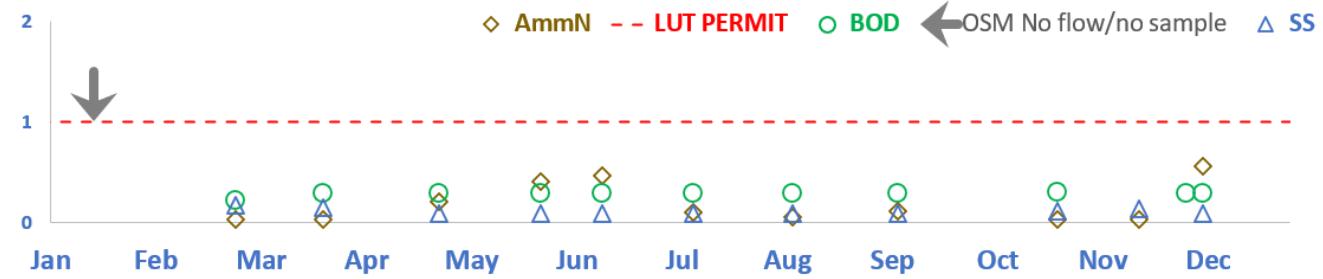
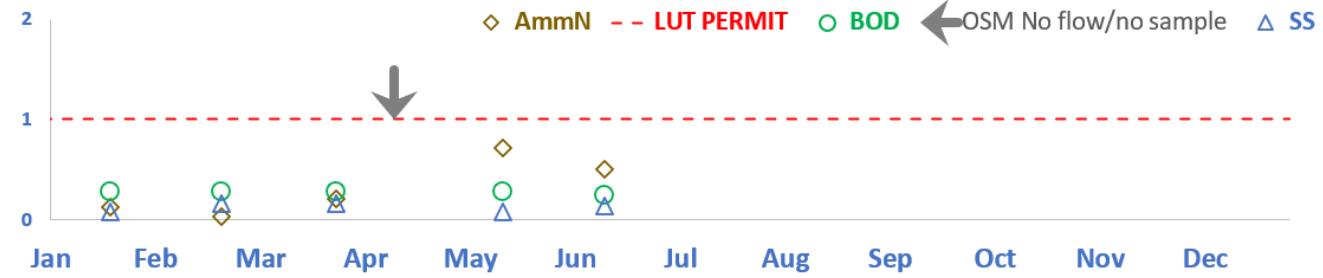
Figure 11: all OSM sample results for 2024 (up to June) for Hampstead Norrys STW

The "NO FLOW/NO SAMPLE" claims in 2022 and 2023 appear, in general, to coincide with some effluent flow (see below)

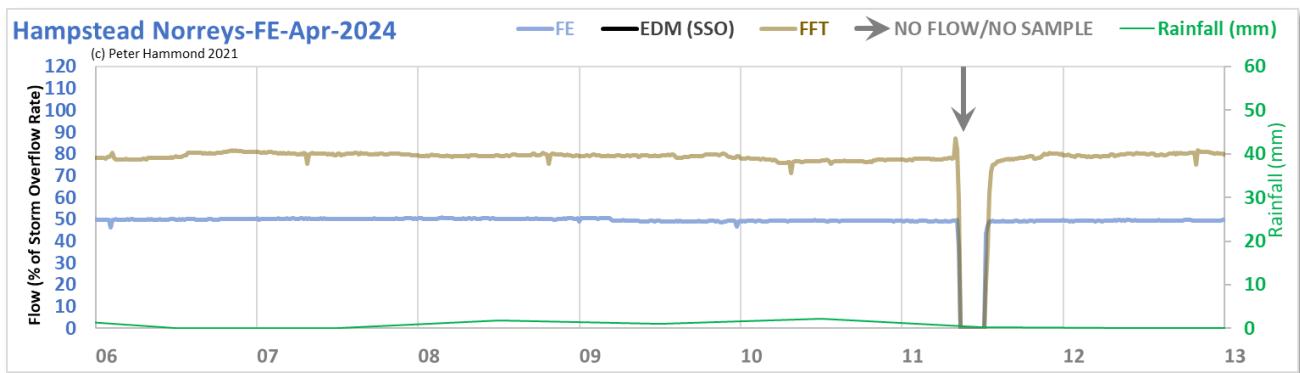
**Figure 12: rainfall, untreated/treated sewage and OSM no flow at Hampstead Norreys STW in April 2024**

On the 5 days prior to the day of the no sample claim on November 11<sup>th</sup> 2024, the sewage flow to full treatment (FFT) was at about 80% of capacity and final effluent flow was at about 50%. Just before the time of the no flow sample, both flows drop to zero and a short time afterwards rise back to the previous levels (Fig. 12).

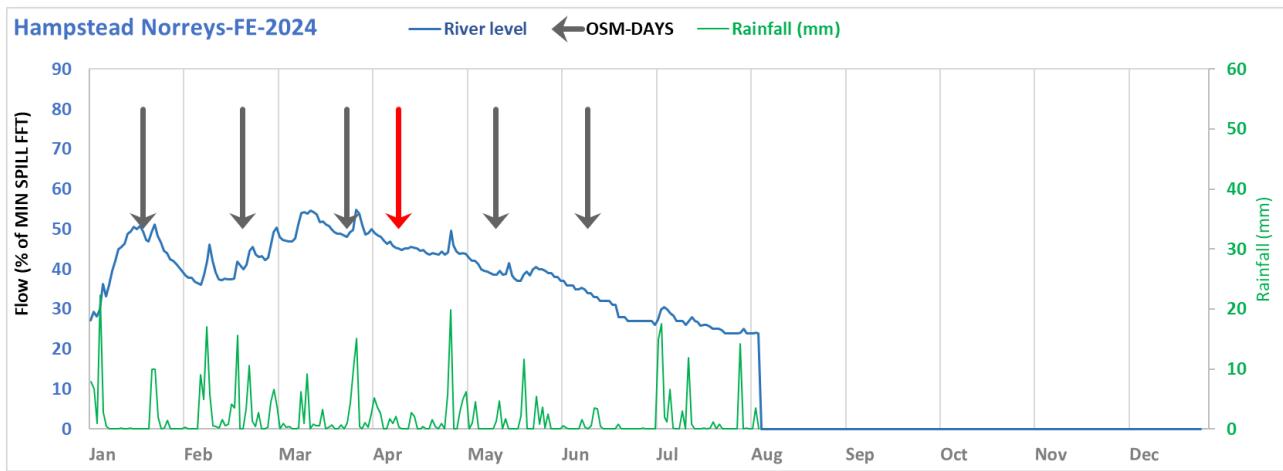
**Figure 13:** rainfall and river flow at Hampstead Norreys alongside 6 OSM sample dates in 2024

The river level (Fig. 13) was raised during the first 5 months of 2024. Nevertheless, samples were obtained every month, apart from April when the no flow occurred (shown as **red arrow**). It seems unlikely, therefore that flooding of the outlet could be used as an excuse.

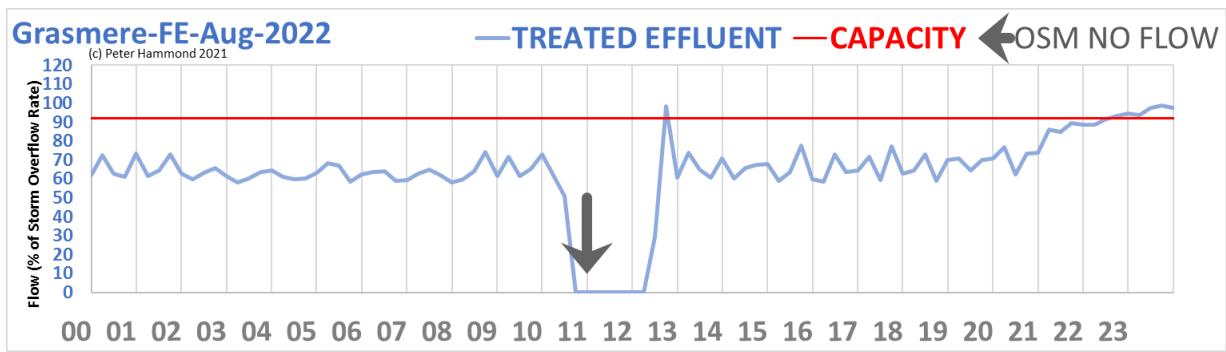
Figure 14: treated effluent flow, storm overflow capacity and OSM “no flow” on August 8<sup>th</sup> 2022

On the day of the “NO FLOW/NO SAMPLE” sample, treated effluent flow at Grasmere STW starts at 60%-70% of storm overflow capacity but drops to 0 at 10:45 am (Fig. 14). An OSM sample is attempted at 11 am but “no flow” is recorded and an hour or so later the flow jumps to over 100% capacity and then returns back to 60% to 70% etc. Was this no flow sample engineered or was it genuine?

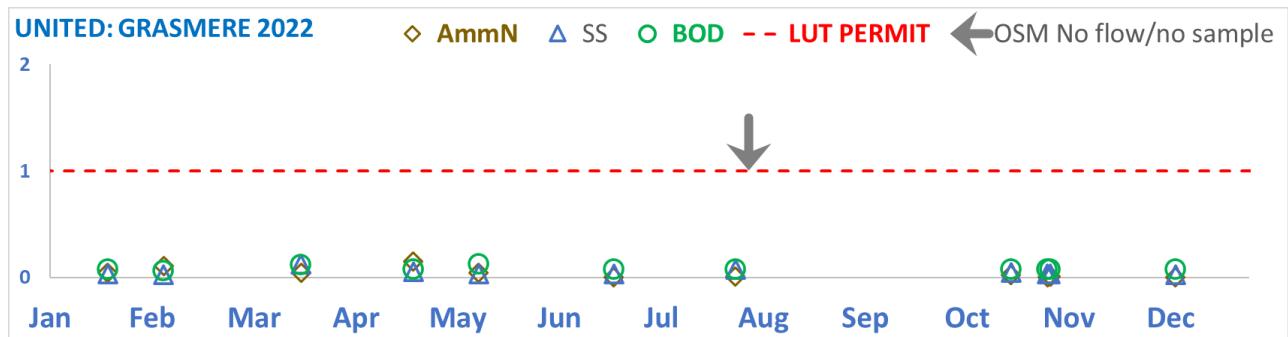
The drop in flow at Grasmere was a result of an enhancement project to install new tertiary treatment feed pumps and tertiary treatment process units.

If the enhancement project was preplanned why was the sampler not warned that during this period there would be no point in attempting to take a sample?

Why did the sampler not reschedule? Why was no sample taken in September 2022?

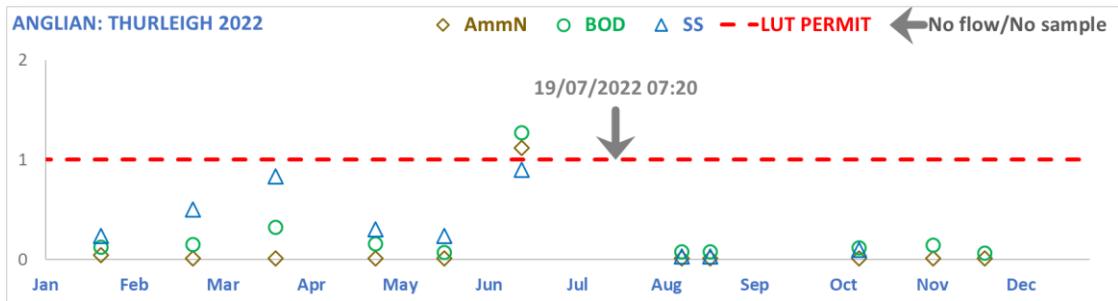
**Figure 15:** 2022 OSM data for Thurleigh STW with AmmN and BOD exceedances and a NO FLOW/NO SAMPLE

AN-THURLEI THURLEIGH STW F/E 19/07/2022 07:20 NO FLOW/SAMP 0

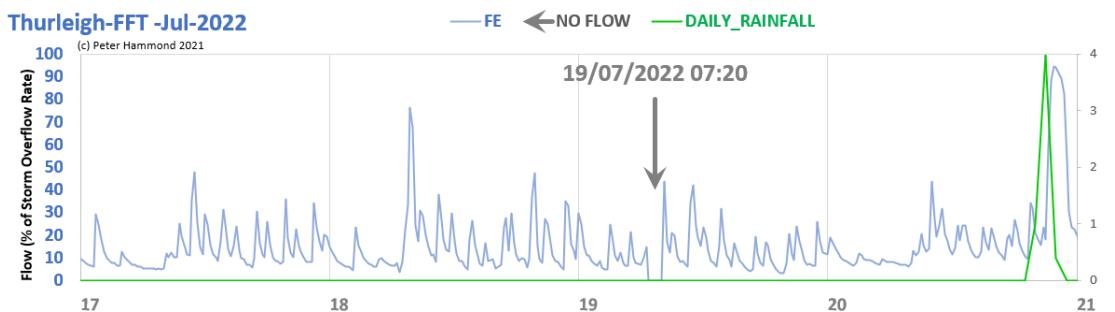
**Figure 16:** Final effluent flow for Thurleigh STW showing a gap in flow enveloping the NO FLOW/NO SAMPLE

WASP was provided with sewage treatment data by the EA that it had previously received from Anglian Water. **Fig. 16** shows the final effluent flow and rainfall for 17<sup>th</sup>-20<sup>th</sup> July 2022. The final effluent flow drops dramatically to zero at 06:30 am, rises dramatically at 08:15 and in between is the record of a NO FLOW/NO SAMPLE at 07:20.

No explanation was provided as to why the flow had dropped so suddenly and then risen again, just as suddenly, over a period of 105 minutes that coincided with an attempted OSM spot sample. There does not appear to have been a rescheduling of this failed sample.

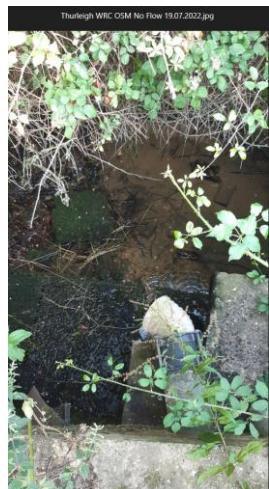
On request, WASP was provided with a photograph of the outfall pipe at Thurleigh STW (**Fig. 17**). The photograph's metadata confirmed it was taken at 2022:07:19 07:18:26.

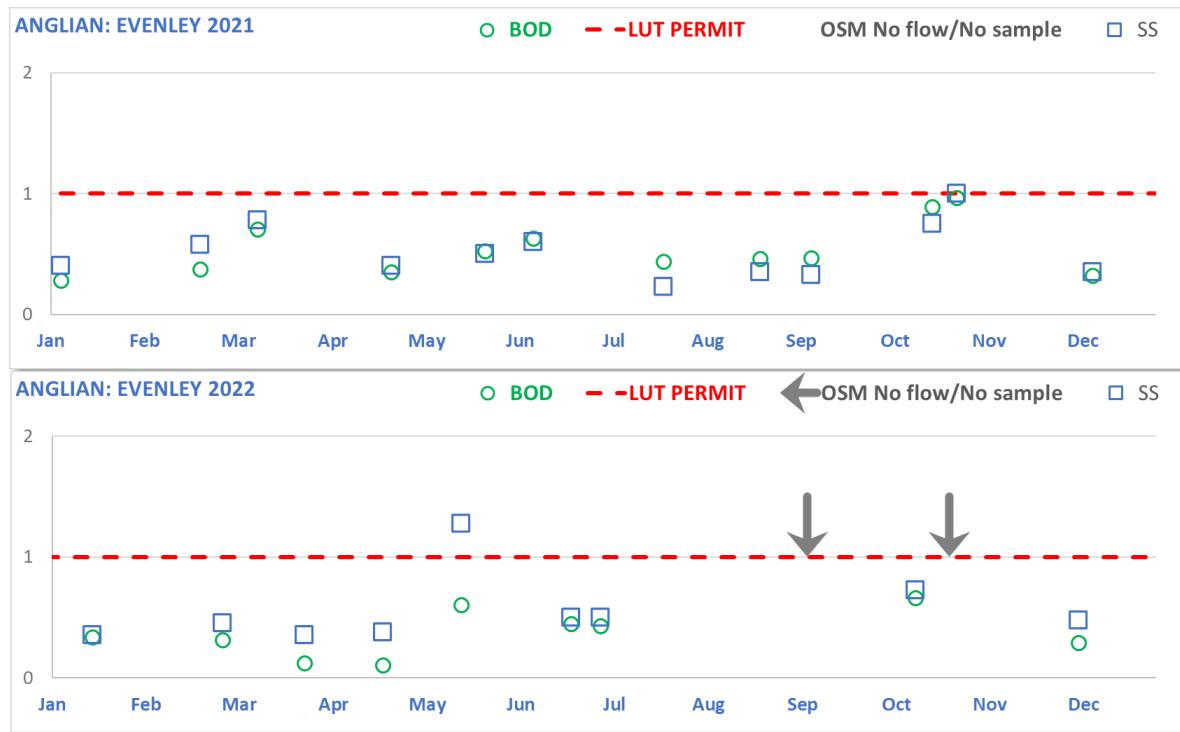
**Figure 18:** OSM test results for Evenley STW in 2021 and 2022 showing 2 NO FLOW/NO SAMPLE records within 12 months of the first of 2 SS exceedances

AN-EVENLEY	EVENLEY STW F/E	07/09/2022 12:49	NO FLOW/SAMP	0
AN-EVENLEY	EVENLEY STW F/E	24/10/2022 11:31	NO FLOW/SAMP	0

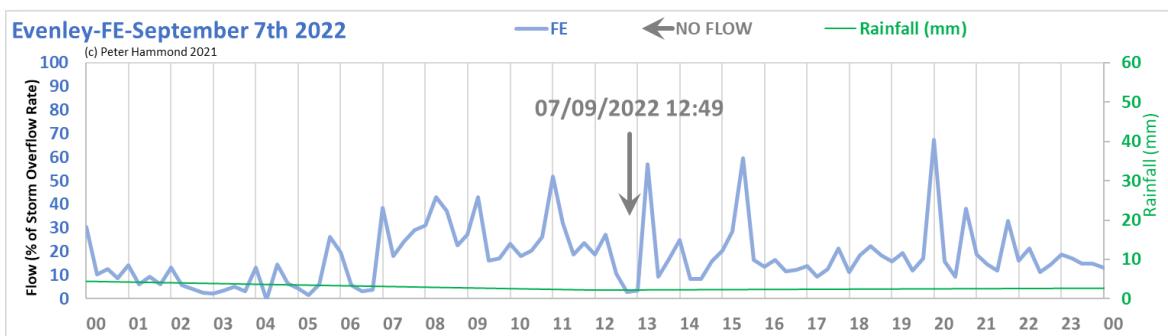
**Figure 19:** Final effluent on Sept 7<sup>th</sup> 2022 at Evenley STW showing gap in flow and NO FLOW/NO SAMPLE claim

Final effluent (FE) flow data provided to WASP by the EA, and to the EA by Anglian Water, is shown in **Fig. 19**. The NO FLOW/NO SAMPLE claim coincides with less than 1 hour of low/no flow. Was this a coincidence or engineered to avoid a third exceedance and potentially a permit breach?

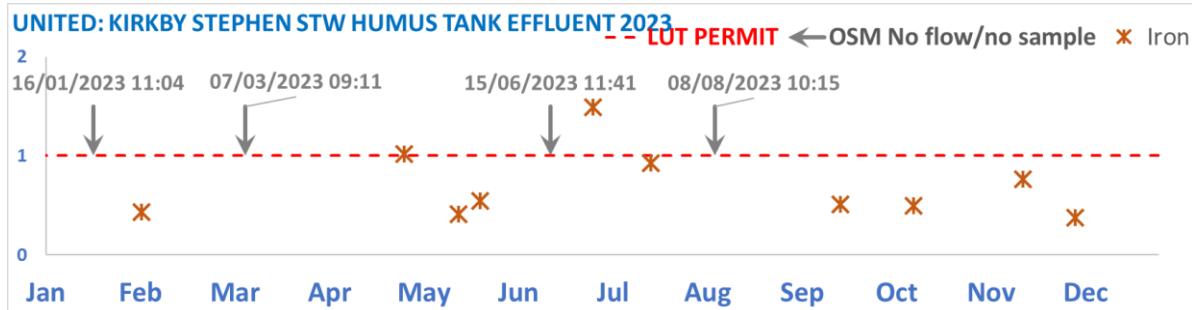
Figure 20: 2023 OSM data at Kirkby Stephens STW showing 2 Iron exceedances, 4 NO FLOW/NO SAMPLES

Kirkby Stephens STW discharges to the River Eden in Cumbria. It rises on Black Fell Moss and flows through the Vale of Eden and Solway Plain before it reaches the sea at Solway Firth. In 2023, Kirkby Stephens STW was struggling to keep *Iron* levels in its final effluent below the LUT permit level of 4,000 µg/l – in fact, it exceeded the limit on 2 occasions (Fig. 20).

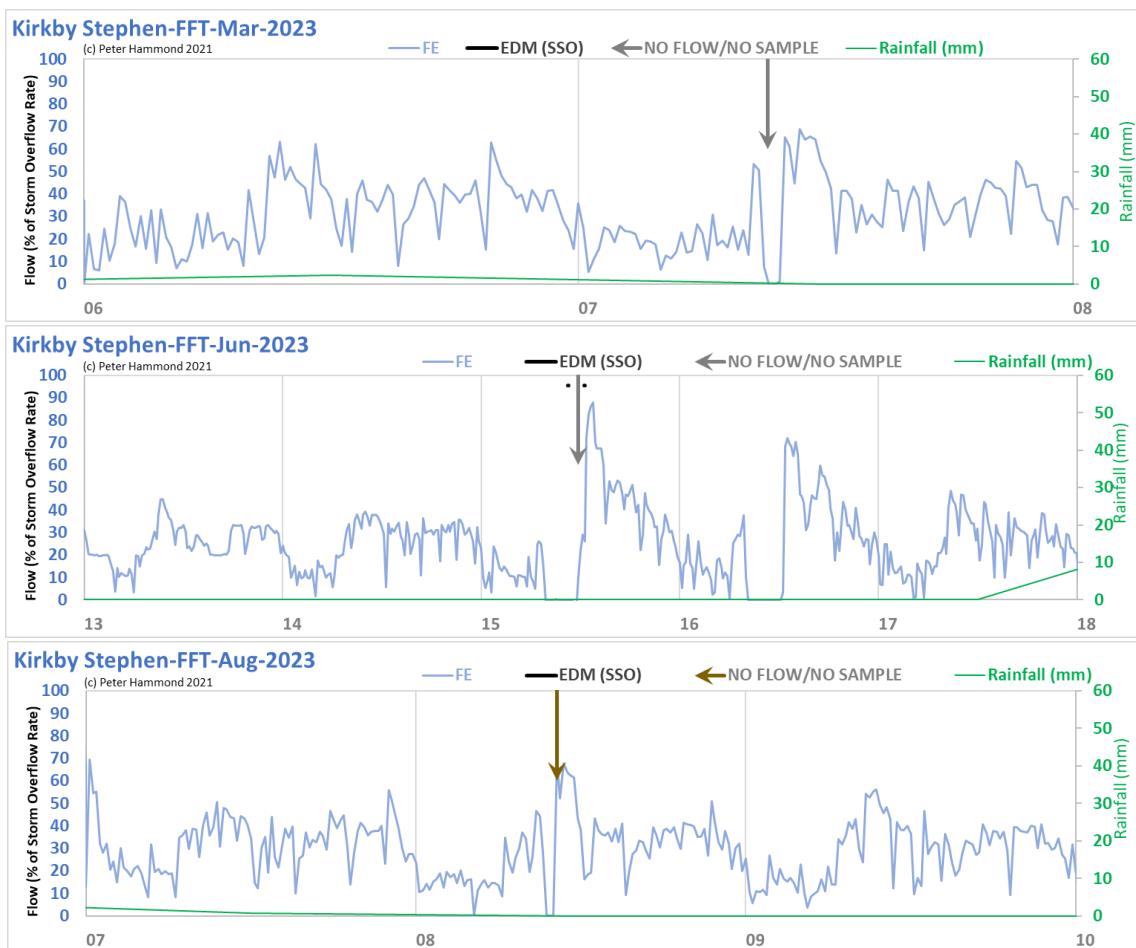
Figure 21: final effluent flow data for Kirkby Stephen STW showing gaps in flow coinciding with NO FLOW/NO SAMPLE claims

NW-88006017	KIRKBY STEPHEN STW HUMUS TANK EFFLUENT	07/03/2023 09:11	NO FLOW/SAMP	0
NW-88006017	KIRKBY STEPHEN STW HUMUS TANK EFFLUENT	15/06/2023 11:41	NO FLOW/SAMP	0
NW-88006017	KIRKBY STEPHEN STW HUMUS TANK EFFLUENT	08/08/2023 10:15	NO FLOW/SAMP	0

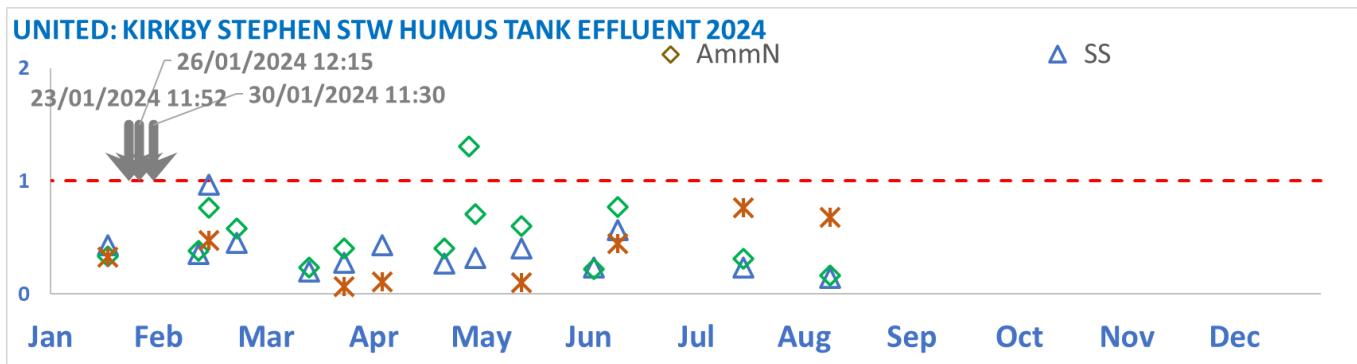
**Figure 22:** 2024 OSM data for Kirkby Stephen STW with 3 “NO FLOW/NO SAMPLE” claims and an AmmN exceedance

The three 2024 “NO FLOW/NO SAMPLE” claims occurred within a week in late January (Fig. 22).

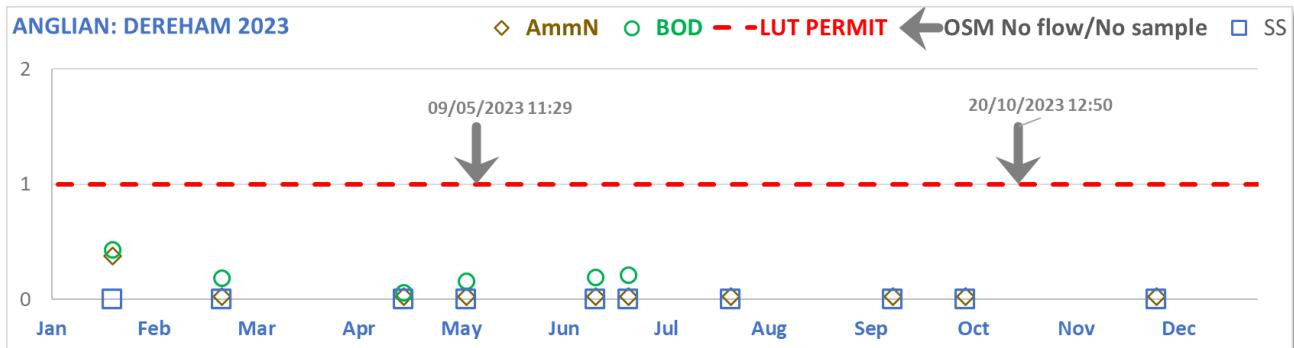
Figure 23: OSM data for 2023 for Dereham STW

AN-DEREHAM	DEREHAM STW F/E	09/05/2023 11:29	NO FLOW/SAMP	0
AN-DEREHAM	DEREHAM STW F/E	20/10/2023 12:50	NO FLOW/SAMP	0

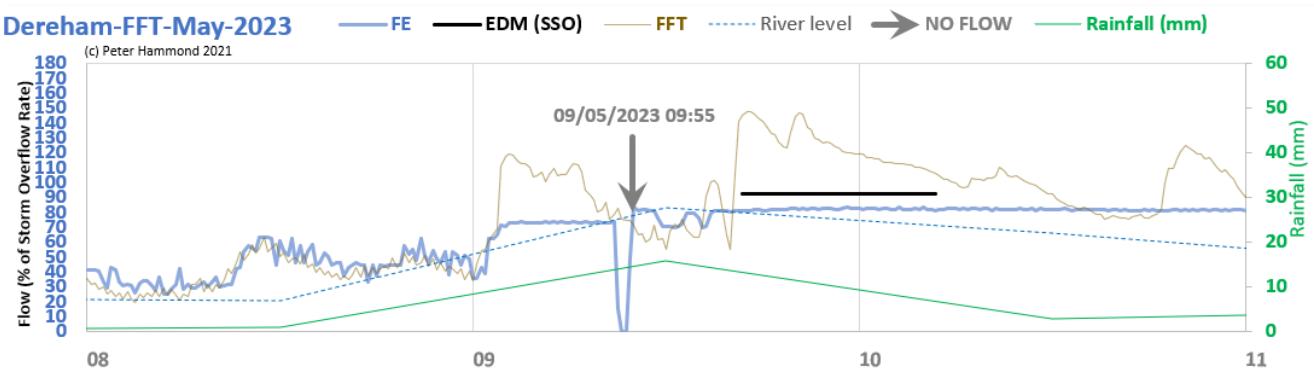
Figure 24 OSM data for 2023 for Dereham STW

WASP obtained Anglian Water's own sewage flow and EDM spill monitoring data. Fig. 24 shows a gap in final effluent flow and the time at which a NO FLOW/NO SAMPLE was recorded.

The river level (dotted line in Fig. 24) was obviously high during this period and the outlet may have been flooded. Yet, the flow to full treatment continues and the final effluent is shown as dropping to zero and then rising again as the SPOT sample is attempted but recorded as failing. WASP would like to see evidence that establishes this NO FLOW/NO SAMPLE as genuine.

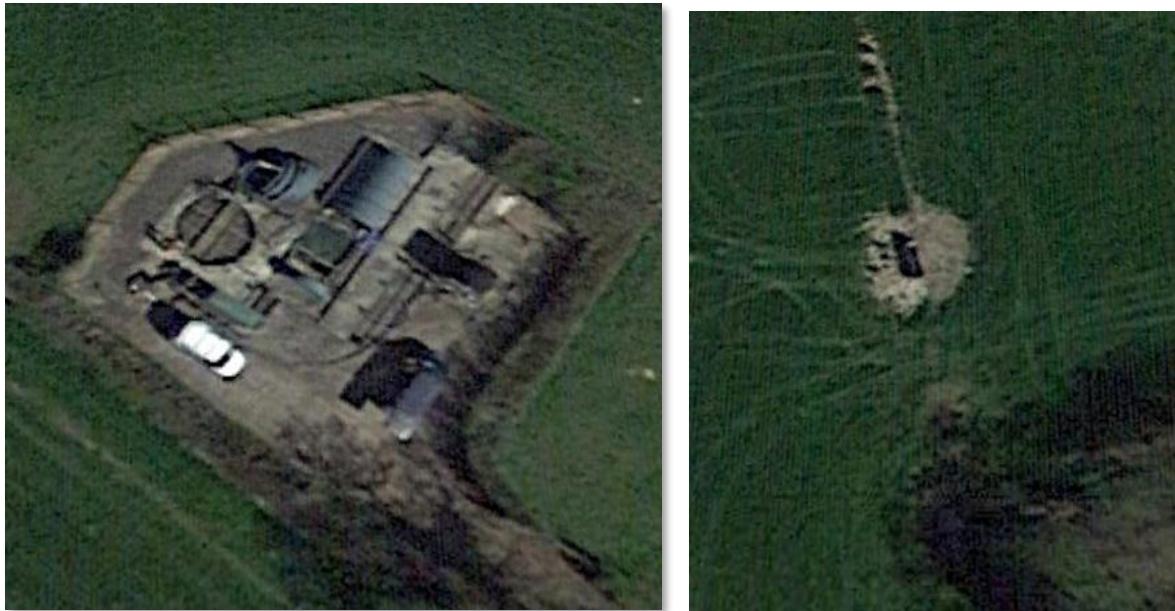
**Figure 25:** a) Nether Peover STW; b) Pond receiving discharges from Nether Peover STW  
(both images: Google Earth)

Nether Peover STW is a very small works (Fig. 25a) and serves a population equivalent of about 300. It is unusual in that it discharges both treated and untreated sewage to a pond in the middle of a field (Fig. 25b) which drains into a drainage ditch that appears dry much of year.

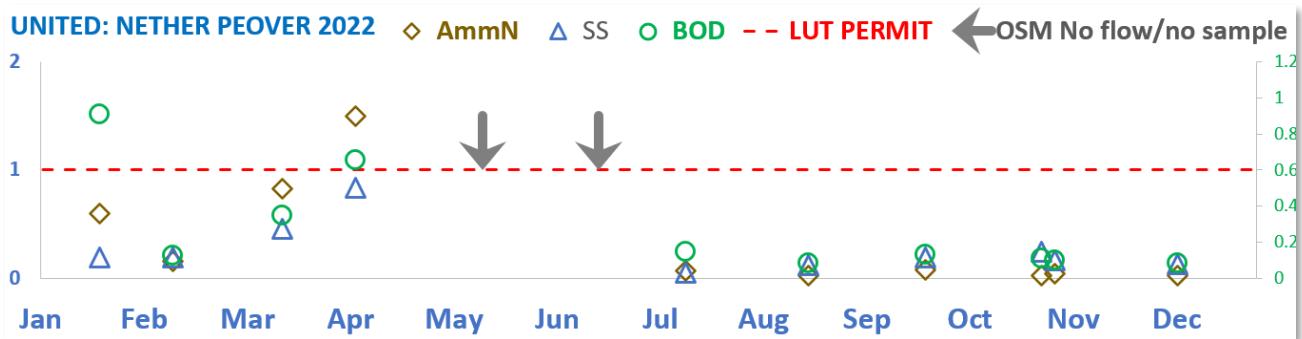
**Figure 26:** 2022 OSM data for Nether Peover STW

NW-88000156	NETHER PEOVER STW HUMUS TANK EFFLUENT	13/05/2022 11:08	NO FLOW/SAMP	0
NW-88000156	NETHER PEOVER STW HUMUS TANK EFFLUENT	17/06/2022 11:38	NO FLOW/SAMP	0

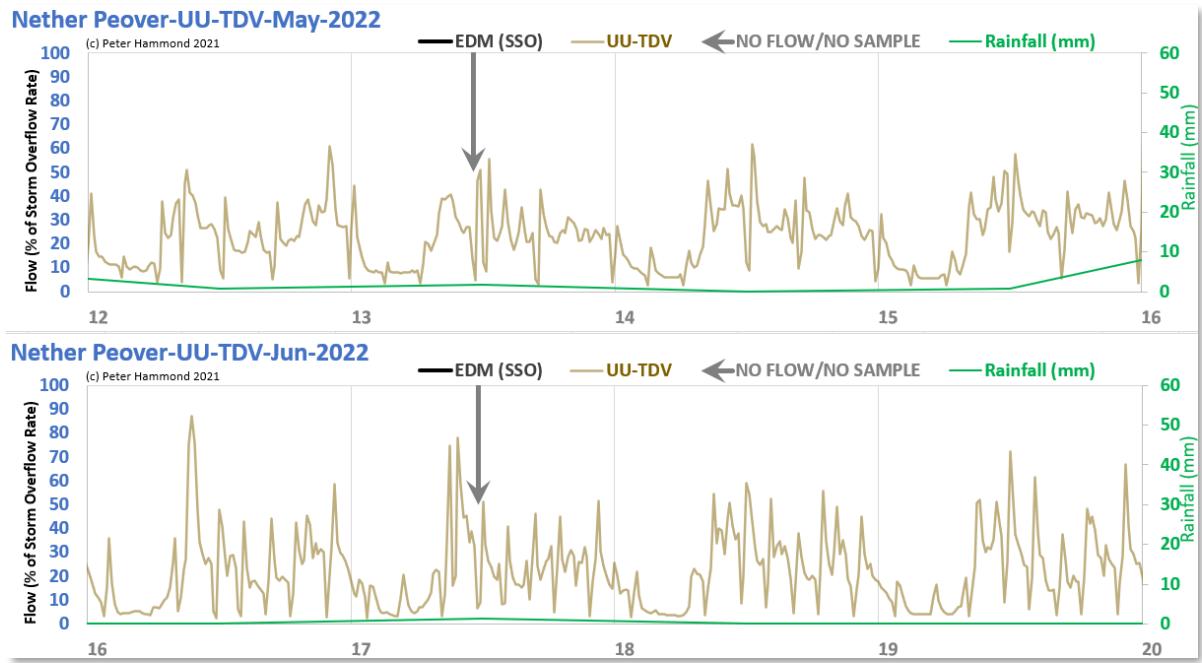
**Figure 27:** flow data with gaps coinciding with OSM NO FLOW/NO SAMPLE claims

which the OSM samples are attempted and are recorded as NO FLOW/NO SAMPLE appear to coincide with points at which the pump is not in operation. Was this an accident of timing or was it a deliberate ploy during the attempted sampling to coincide with low or no flow?

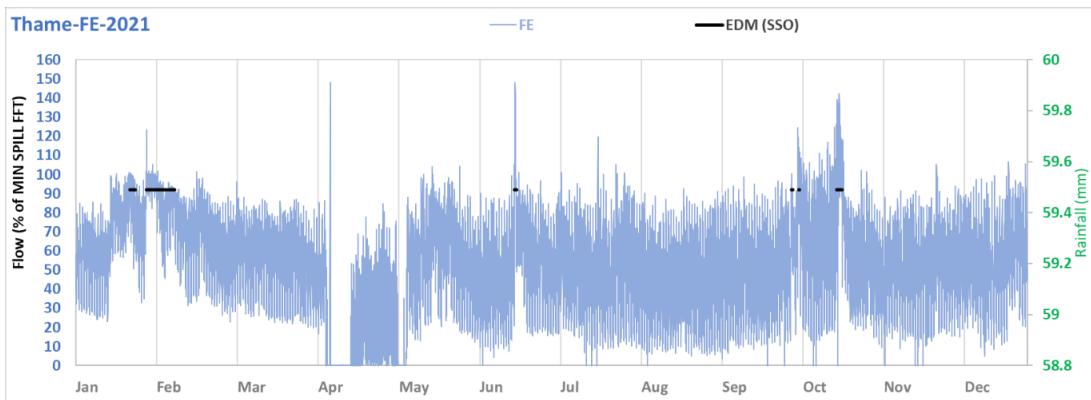
**Figure 28:** 2021 overview for Thame STW showing final effluent (FE) and sewage spills

Thame STW discharges to the River Thame. A summary chart for final effluent for Thame STW for 2021 is shown in **Fig. 28**. Notice that there are just two periods of loss of flow data – in April and May.

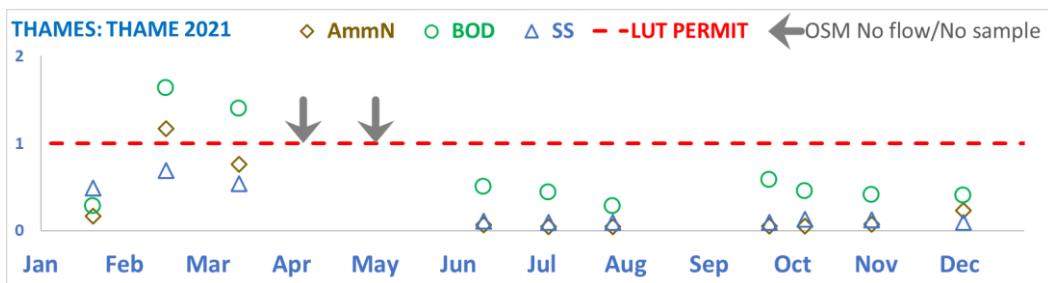
**Figure 29:** 2021 OSM data for Thame STW with 3 exceedances & 1 NO FLOW/NO SAMPLE claims

TH-PTAE0076	THAME STW	08/04/2021 07:50	NO FLOW/SAMP	0
TH-PTAE0076	THAME STW	05/05/2021 08:25	NO FLOW/SAMP	0

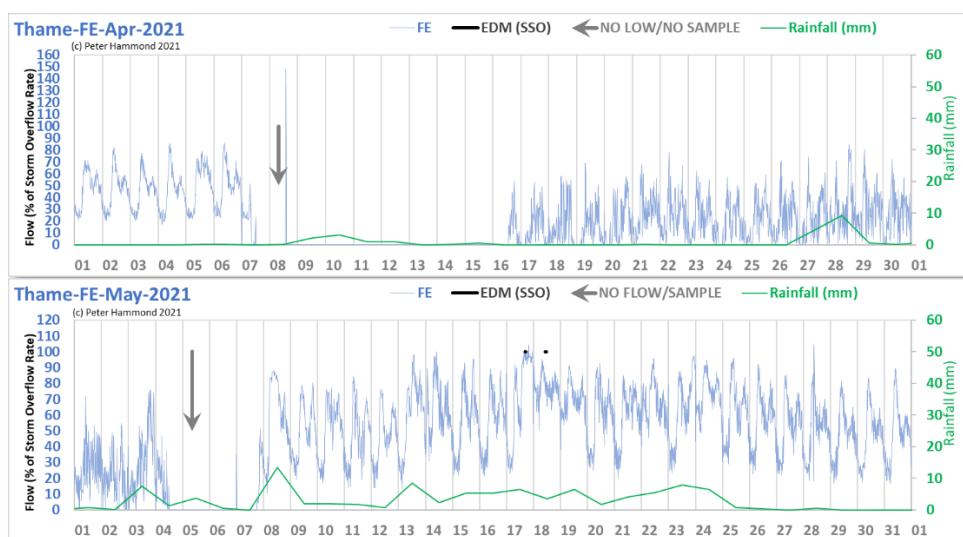
**Figure 30:** final effluent for April and May 2021 for Thame STW

Obviously, a third BOD exceedance would have caused a permit breach. The flow data for April and May show how the NO FLOW/NO SAMPLEs fall in the two extensive gaps in the flow data (**Fig. 30**). Were these genuine or contrived?

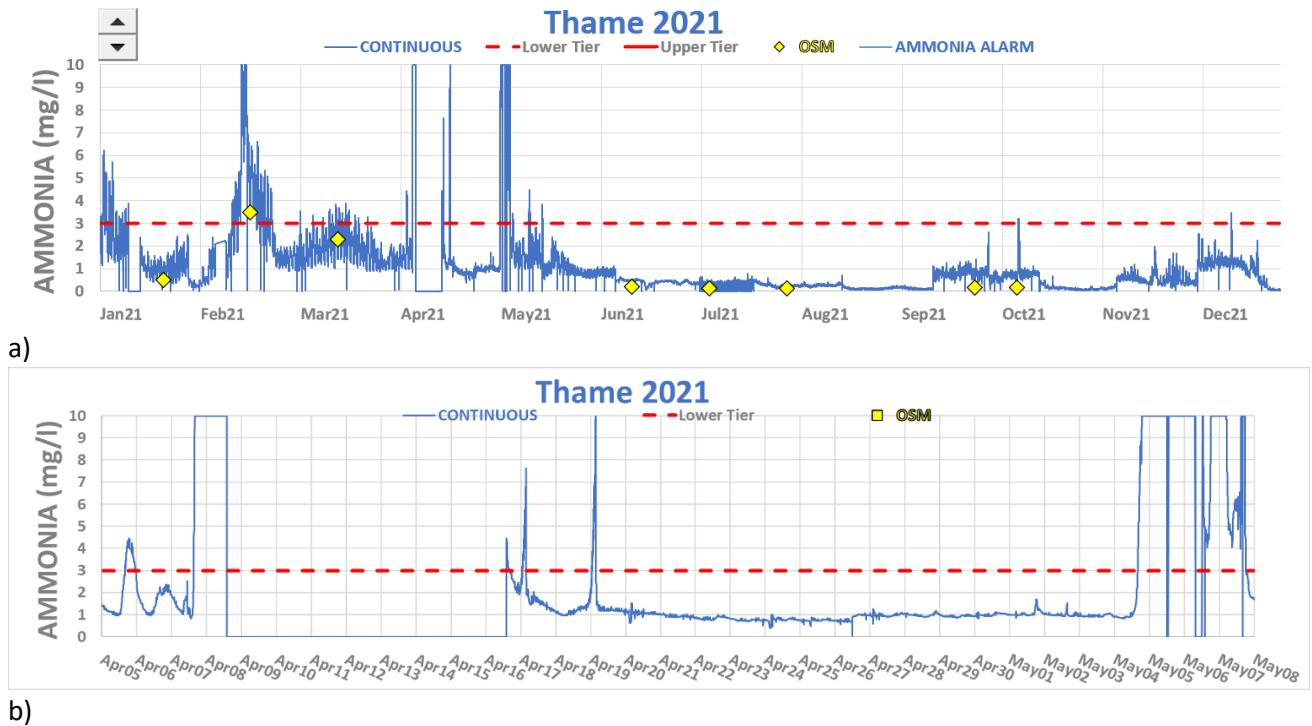
**Figure 31:** AmmN continuous sonde data for Thames STW for 2021

WASP had previously obtained continuous sonde data (blue curve, **Fig. 31a**) for AmmN from Thames Water for 2021. The continuous monitoring data agrees well with the OSM SPOT sample results.

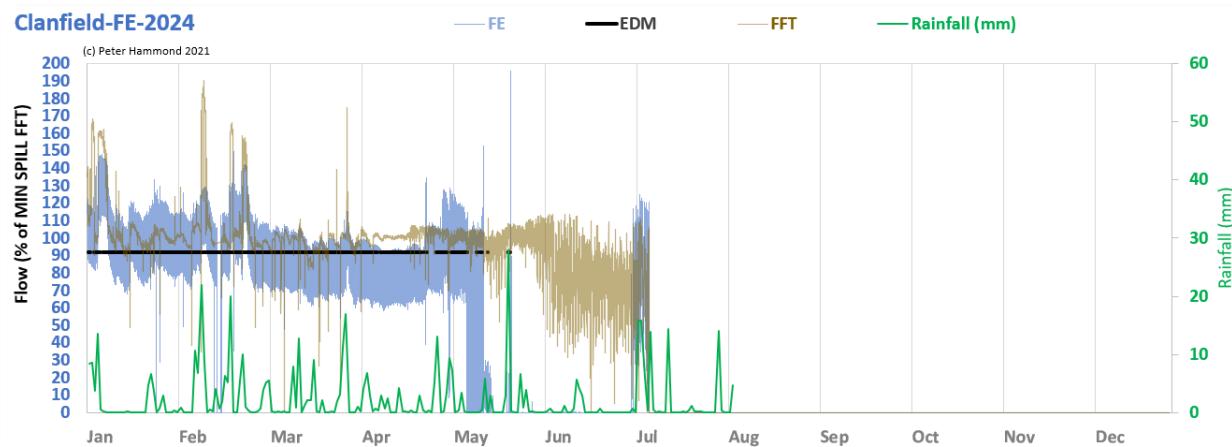
Figure 32: extensive spilling (2,694 hours) at Clanfield STW in the first 5 months of 2024

Clanfield STW discharges to the Clanfield Brook and has been notorious in recent years for illegal spilling. At the beginning of 2024, Clanfield STW spilled extensively for 2,694 hours (Fig. 32).

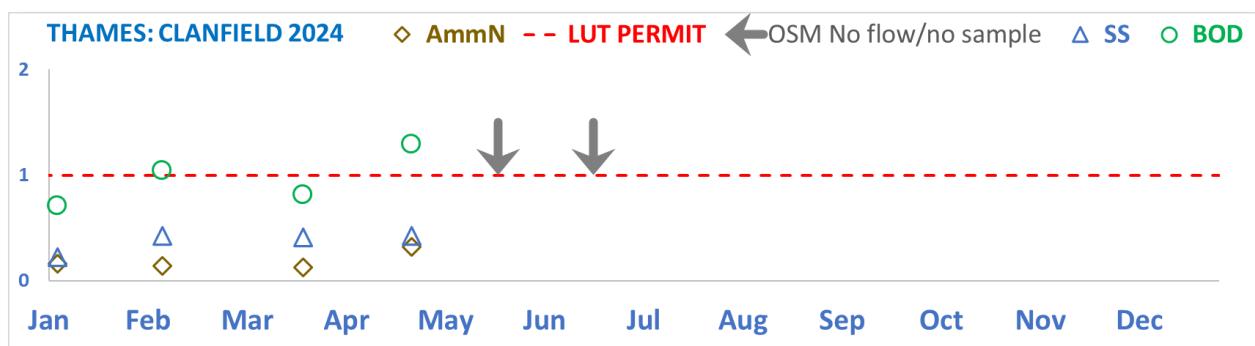
Figure 33: OSM results for 2024 (to July) for Clanfield STW including 2 exceedances of BOD and two NO FLOW/NO SAMPLE claims

TH-PUTE0049	CLANFIELD STW	20/05/2024 09:25	NO FLOW/SAMP	0
TH-PUTE0049	CLANFIELD STW	19/06/2024 07:06	NO FLOW/SAMP	0
