## 20 potential abuses of Operator Self-Monitoring of treated sewage to avoid permit breaches

Peter Hammond  
Windrush Against Sewage Pollution (WASP)  
Version 4 October 24<sup>th</sup> 2024

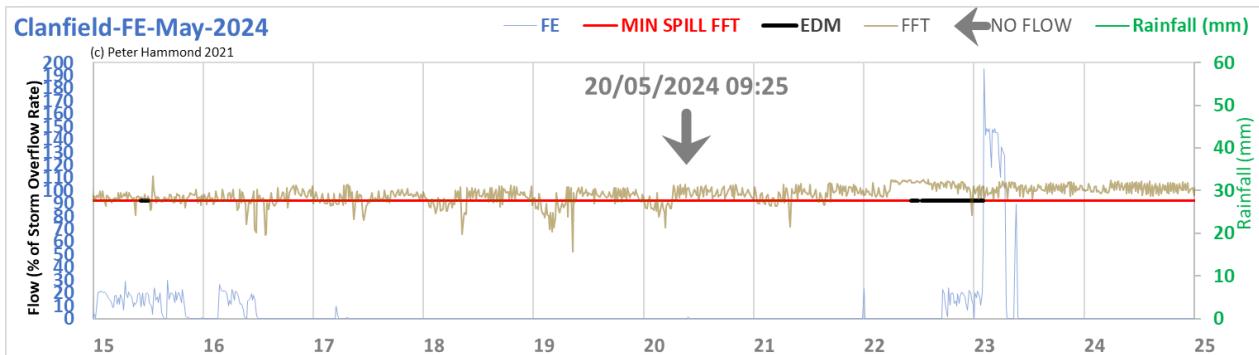
Figure 34: flow to full treatment and final effluent flow at Clanfield STW towards the end of May when one of the NO FLOW/NO SAMPLE claims is made

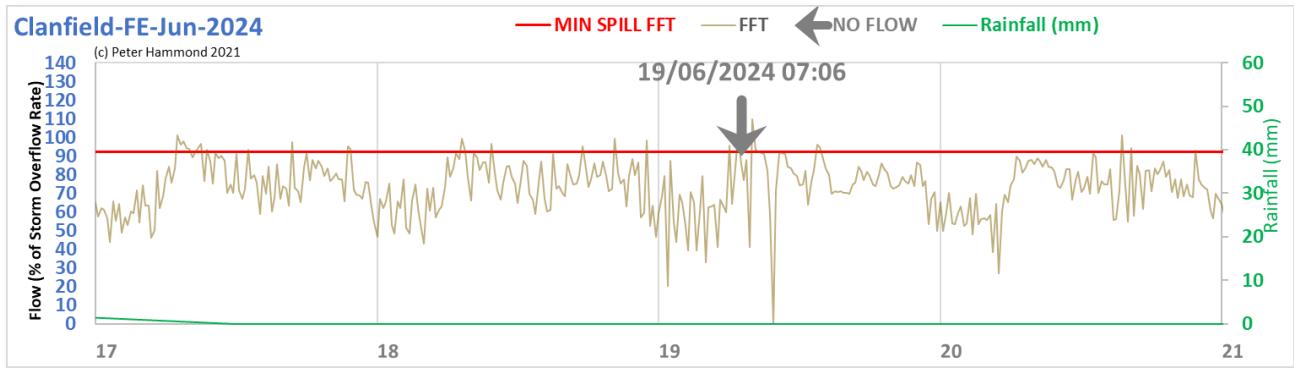
**Figure 35:** flow to full treatment at Clanfield STW towards the end of June when the second of the NO FLOW/NO SAMPLE claims is made

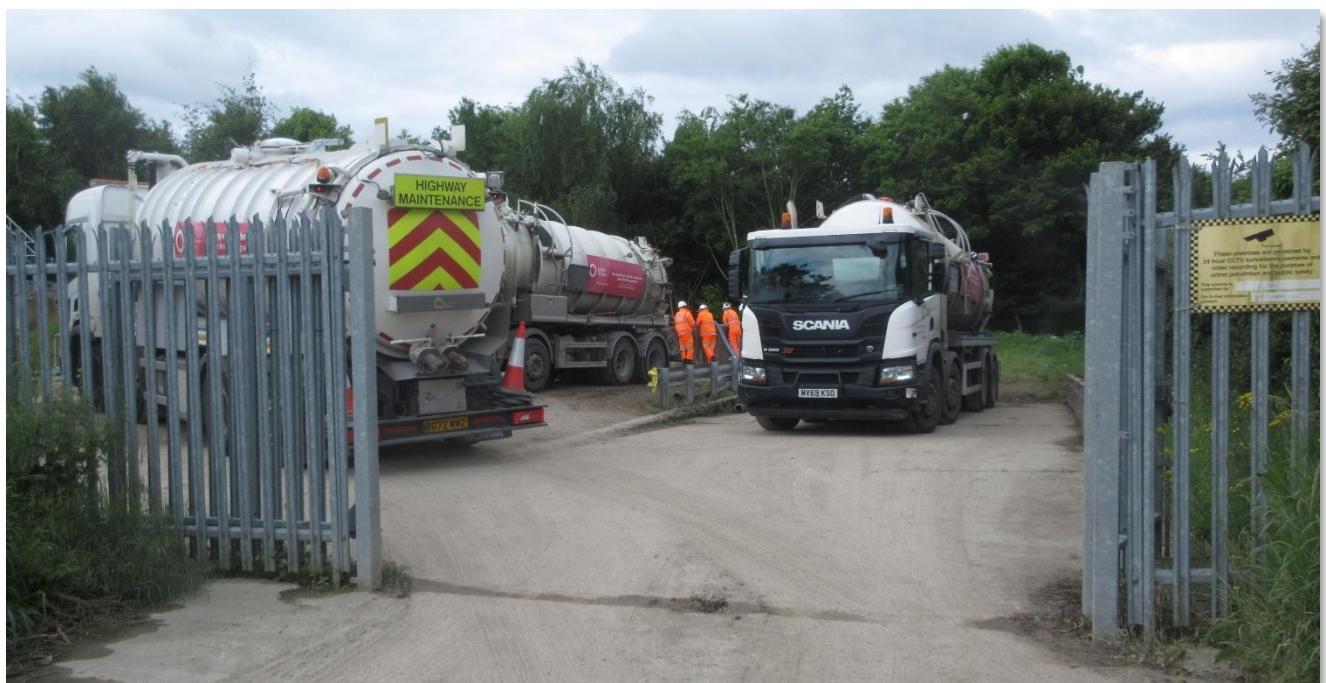
**Figure 36:** tankering of “treated sewage” from Clanfield STW to Witney STW in 2024 (photo: Geoff Tombs)

It is possibly unfair to cite this example, but it does show how potential permit breaches can be avoided especially when a works such as Clanfield STW is failing dramatically.

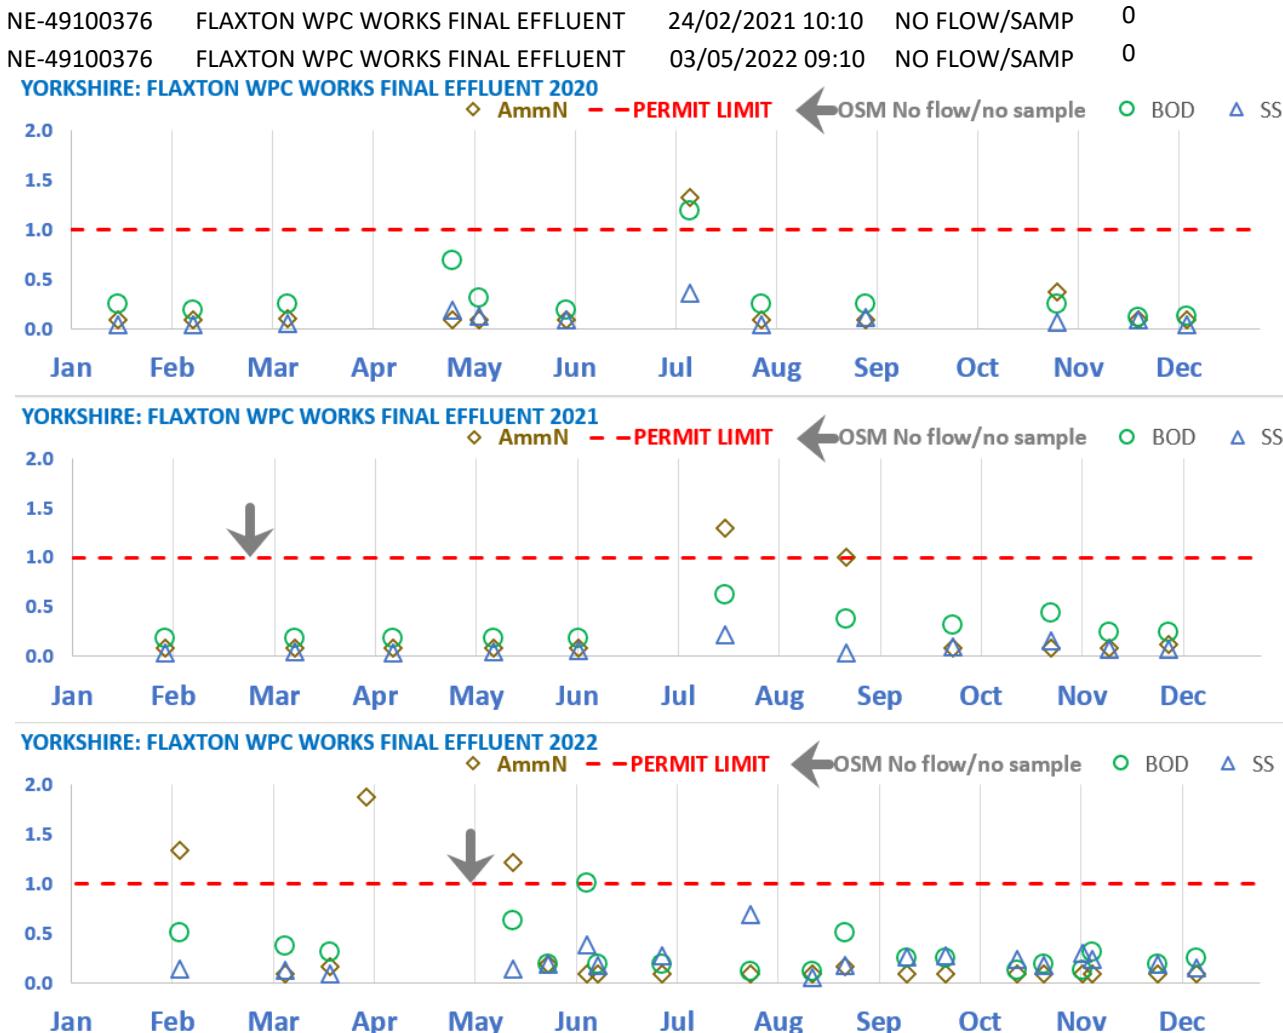
Figure 37: OSM data for Flaxton STW for 2020, 2021 and 2022 showing several exceedances of Ammonia

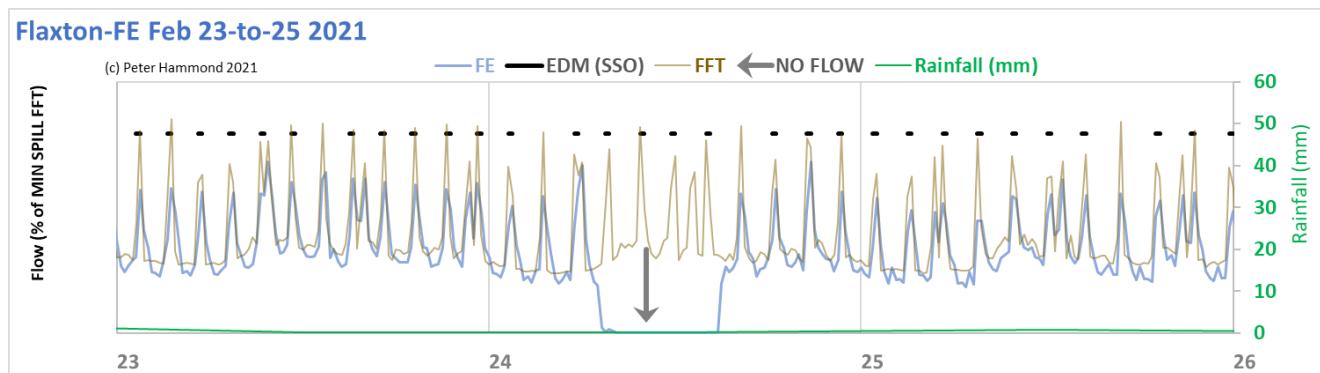
Figure 38: flow to treatment and final effluent flow data for Flaxton STW for Feb 23-25 2021

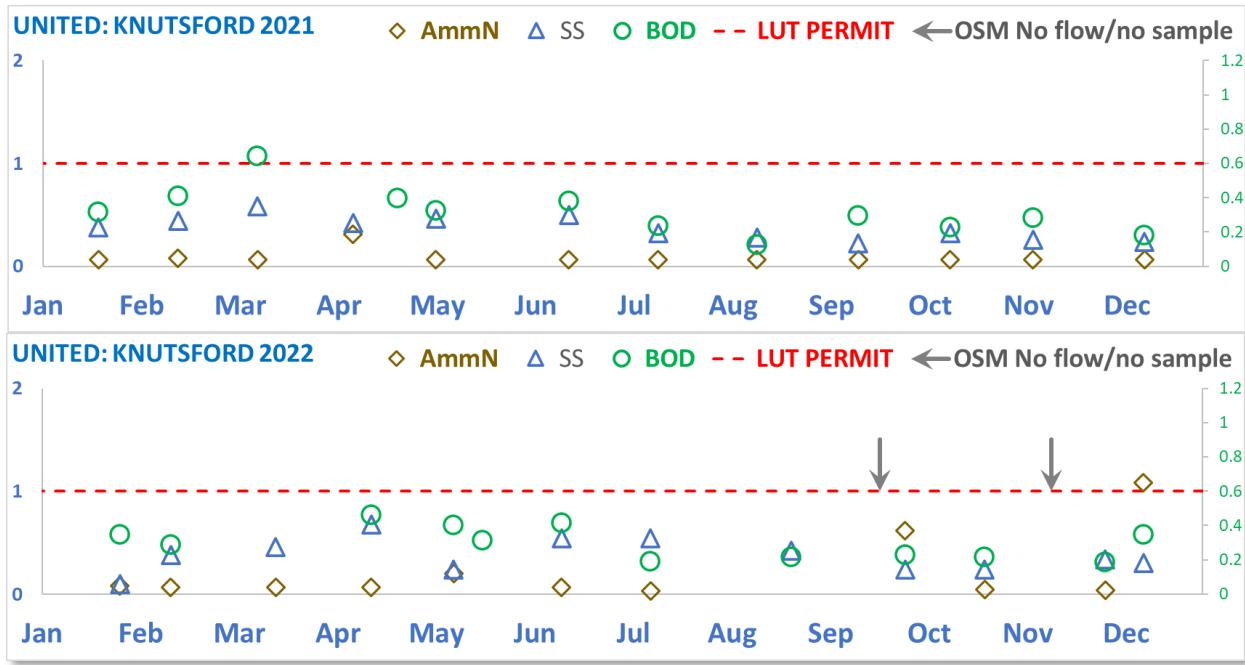
Figure 40: 2021 and 2022 OSM data for Knutsford STW

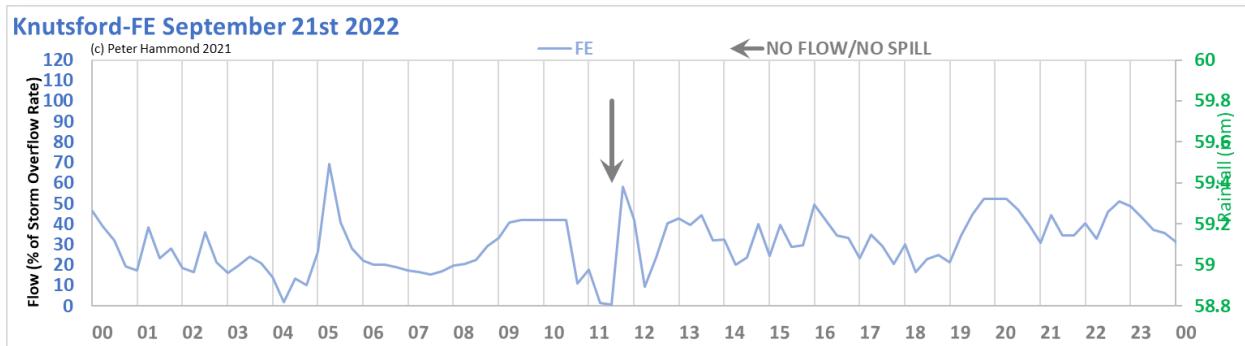
Figure 41: final effluent flow for Knutsford STW for September 21<sup>st</sup> 2022

The final effluent begins to drop rapidly at 10:30 am and rises quickly at 11:30 am with the attempted SPOT sampling failing at 11:31 am. Was this a genuine loss of flow or was it artificially engineered?

An electrical power failure in the local network resulted in a drop in flow at Knutsford. Power was restored quickly, and the plant brought back into full operation.

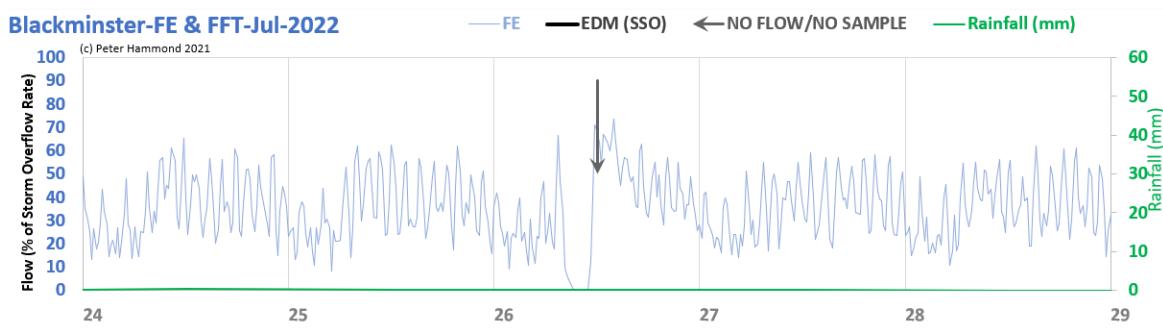
**Figure 42:** final effluent data for Blackminster STW for July 24-28 2022 showing a sudden loss of flow coinciding with the “NO FLOW/NO SAMPLE” claim

Our regulatory sampler (ALS) attended site as there was “no flow” in the sample chamber so as per our documented procedure we captured photographic evidence & investigated the cause. It was a blockage in the chamber so the action was to “clean anoxic chamber to ASP”. It was recorded, reported and actioned as per the usual procedures / so is essentially an operational site issue that was identified, looked in to and sorted - the suggestion of anything else is absolutely absurd.
